MLA/2025/00263 – Report of the Investigation of the Sediment Quality Data of L/2015/00427/7

Representation from North East Marine Research Group
(NEMRG)

The document provides the working behind why NEMRG's representation¹ makes the recommendations for restrictions to be imposed as part of the renewal of the River Tees maintenance dredging licence.

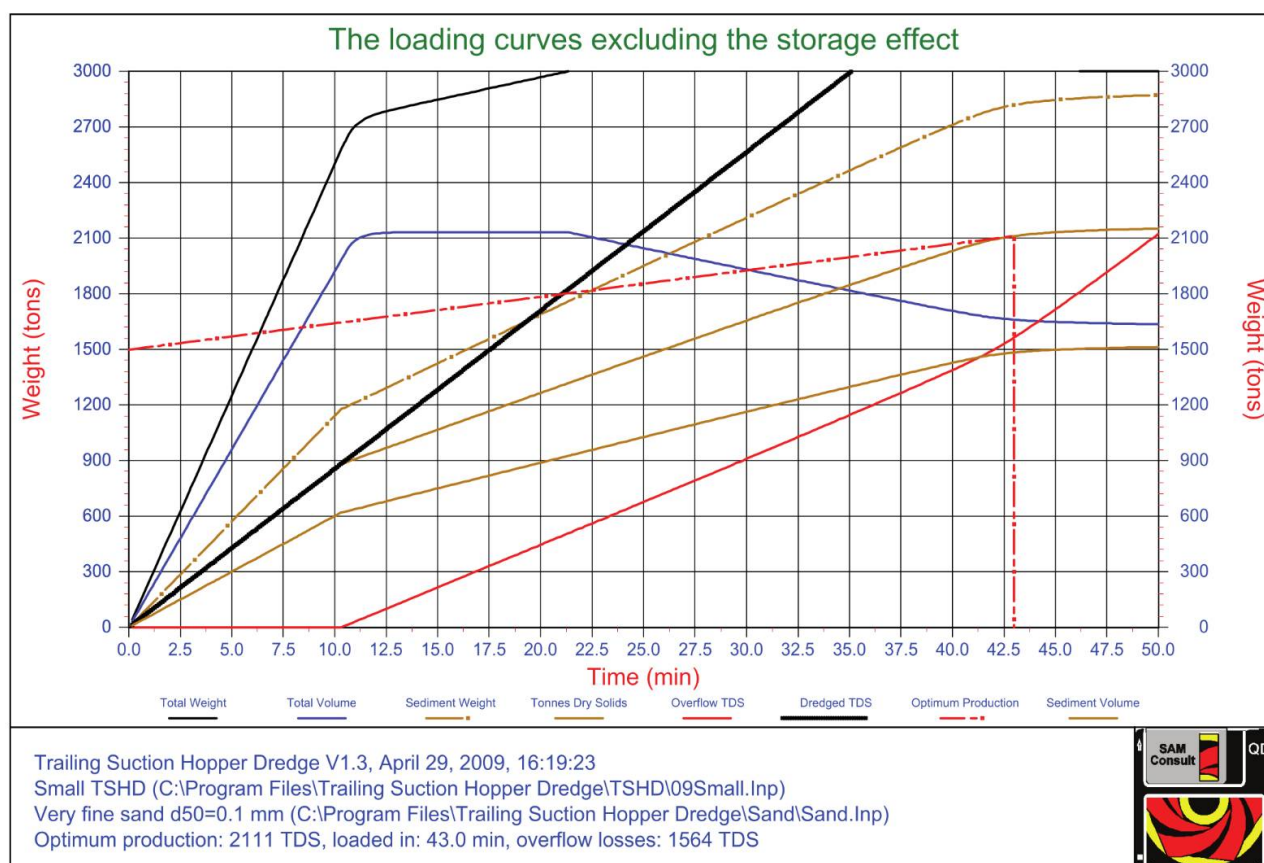
Illustration 4: The loading curves for the Small TSHD

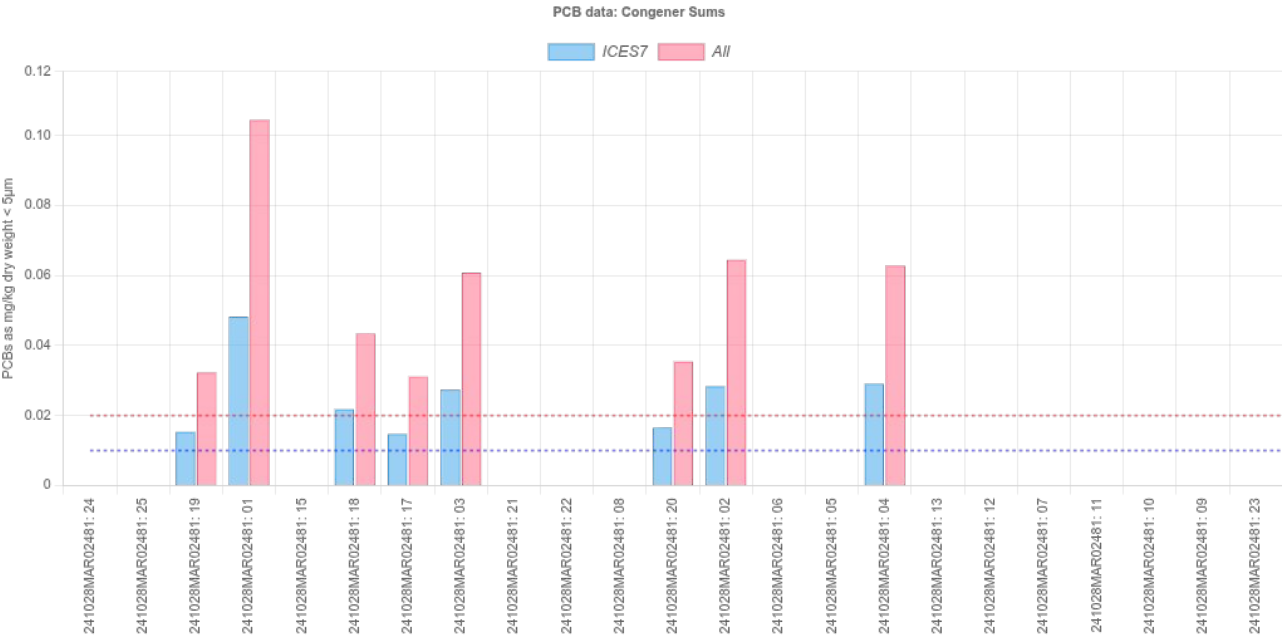
Also no relationship is observed between hydrophobic organic contaminants and silt/clay fraction or with between hydrophobic organic contaminants and organic matter.

Figure 8: 2024 Samples PCB sums ordered by silt/clay fraction

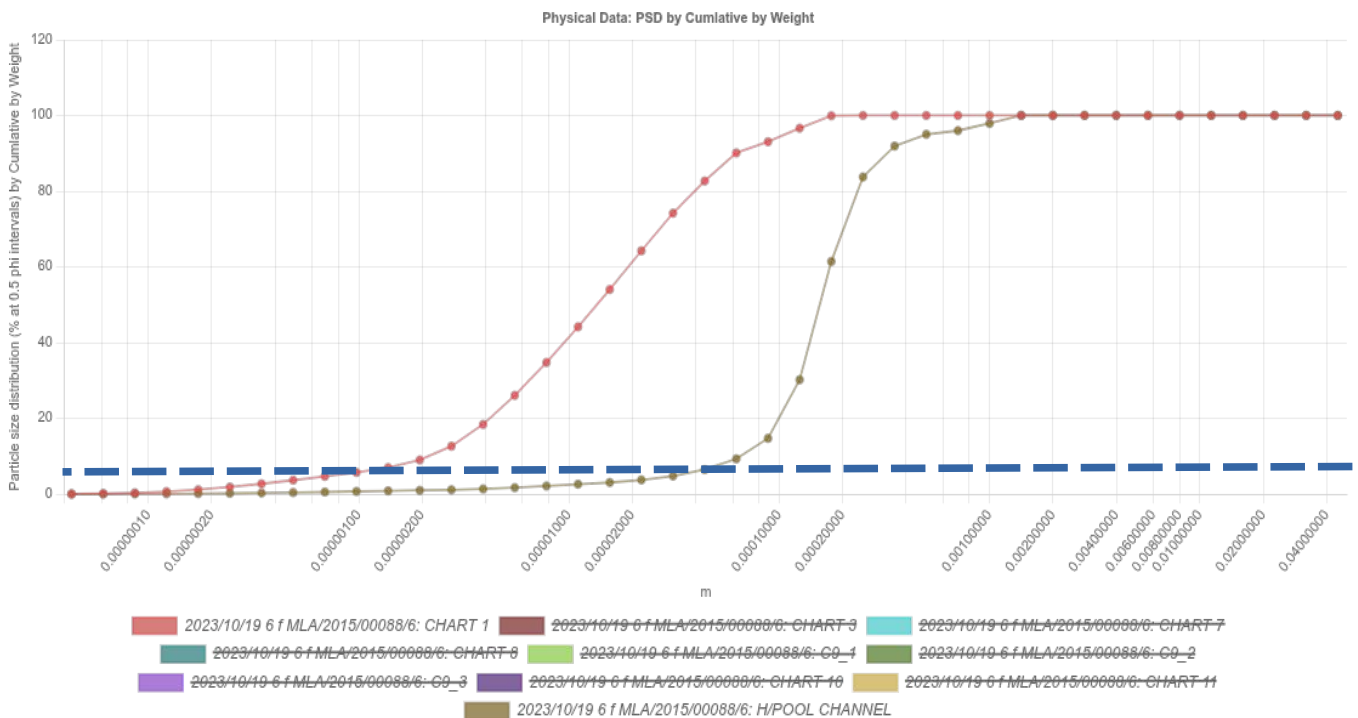
Figure 10: 2023 Samples PSD by cumulative weight

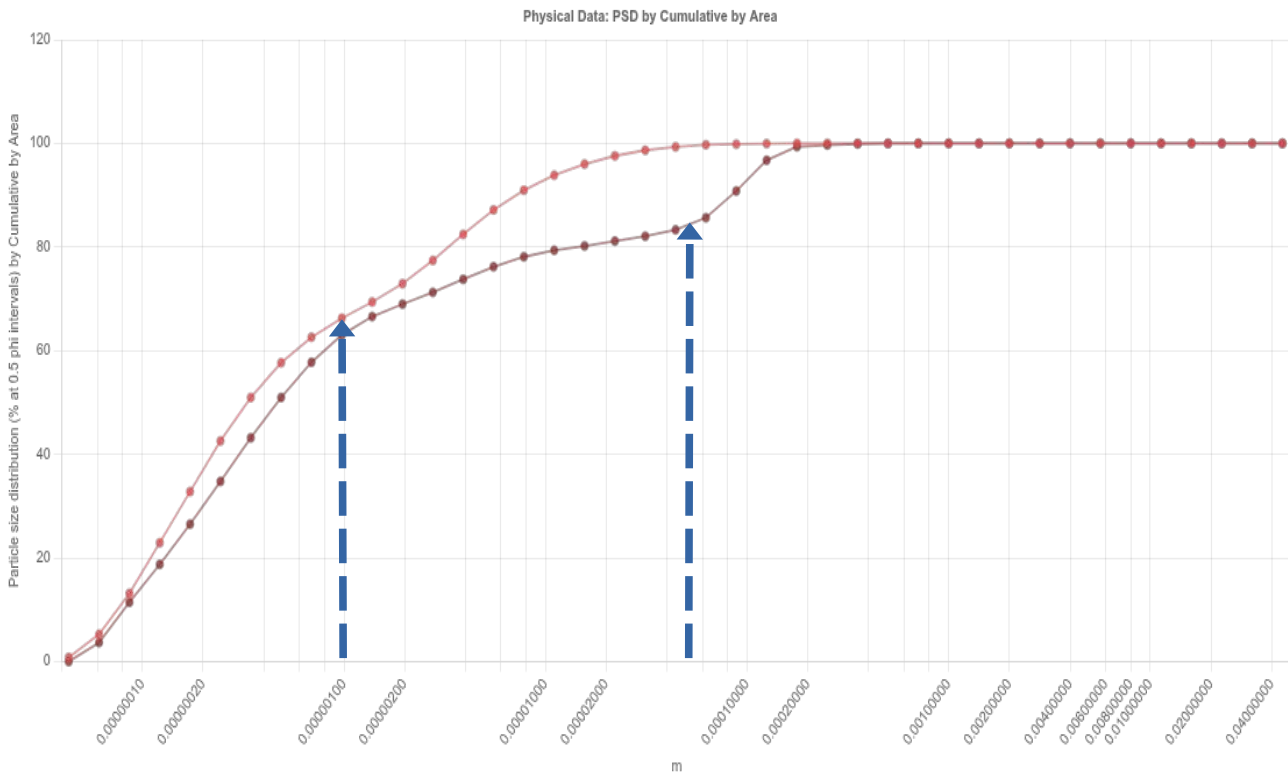
So with 5% overspill for Chart 1 the sediment particles overspilled make up 67% of the surface area, whereas for Hartlepool Channel this is 84%.

Figure 11: 2023 Samples PSD by cumulative area

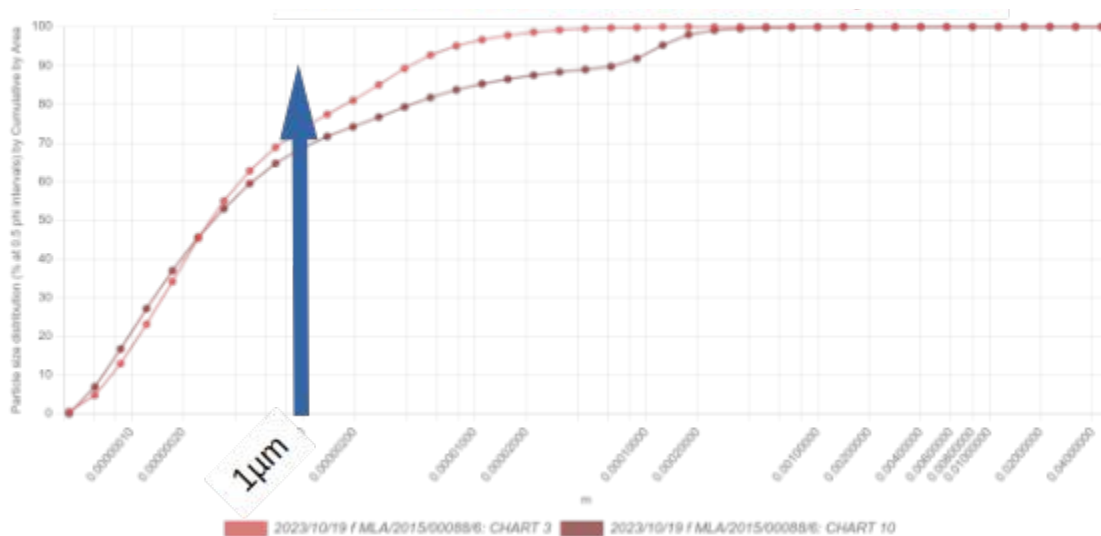
Figure 12: 2023 Samples PSD by cumulative area
NEMRG

This relationship can be used to estimate the toxicity of particles below a certain size. For example for two sample, one exceed the Gorham Test Protocol HMW ERM, but the other is well below it. However, if the fraction of contamination on 1μ is calculated as a weight contamination level, then both samples fail the Gorham Test Protocol for HMW ERM and LMW ERM.

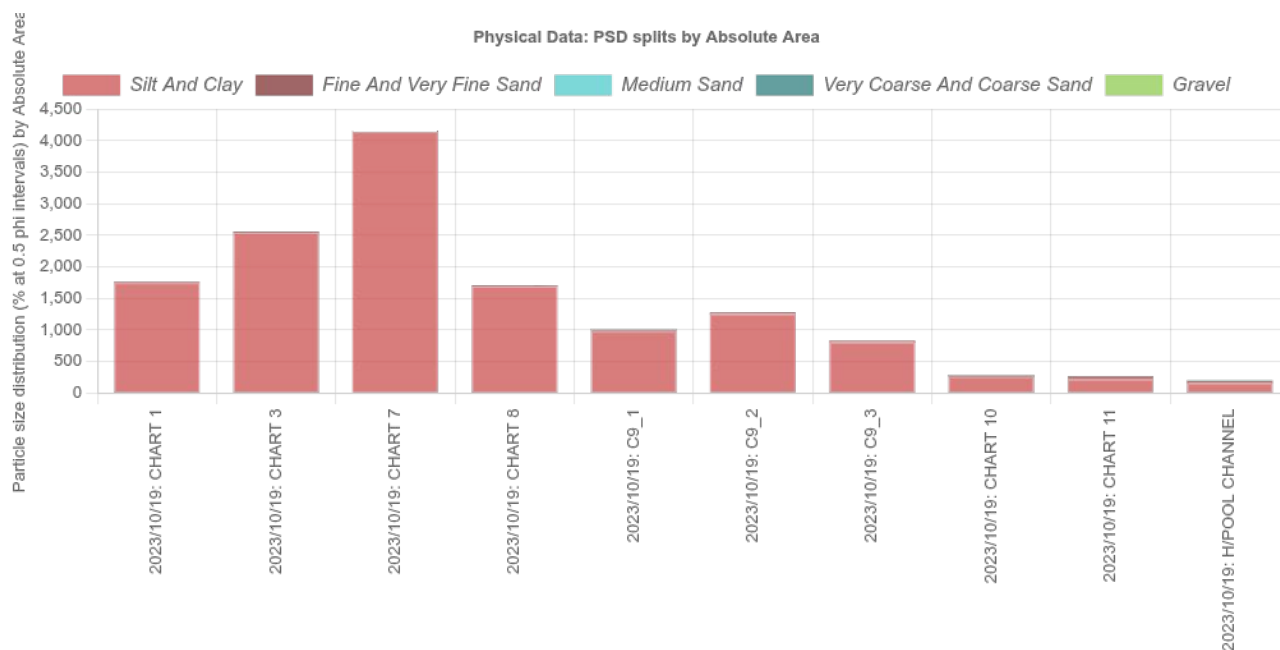
For this sample set the relative surface area of the samples shows the assumed pattern that upstream samples are mainly slit / clay and downstream samples are mainly sand. Chart position 7 is surprisingly the sample with the largest surface area.

Figure 15: 2023 Samples relative surface area

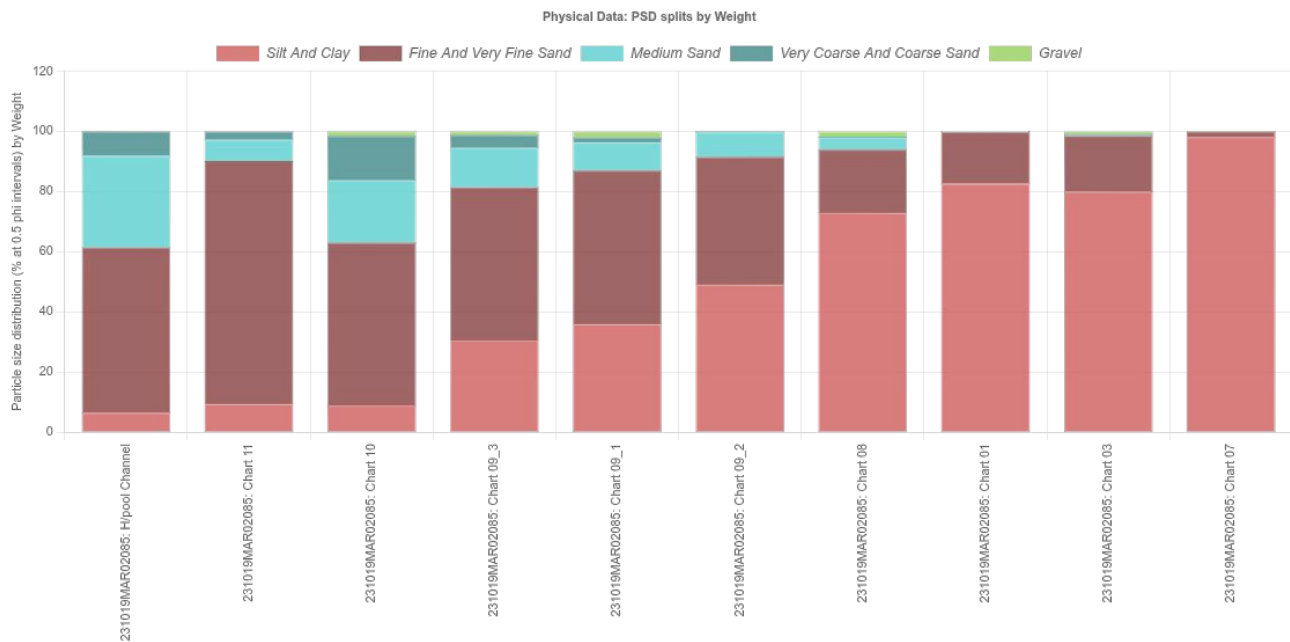
Figure 19: 2023 Sample composition
