## **Tees Maintenance Dredging Water Environment Regulations (WER) Compliance Assessment**

Renewal application for L/2015/00427/7

Client: PD Teesport Limited

Reference: PC6304-RHD-XX-XX-RP-X-0001

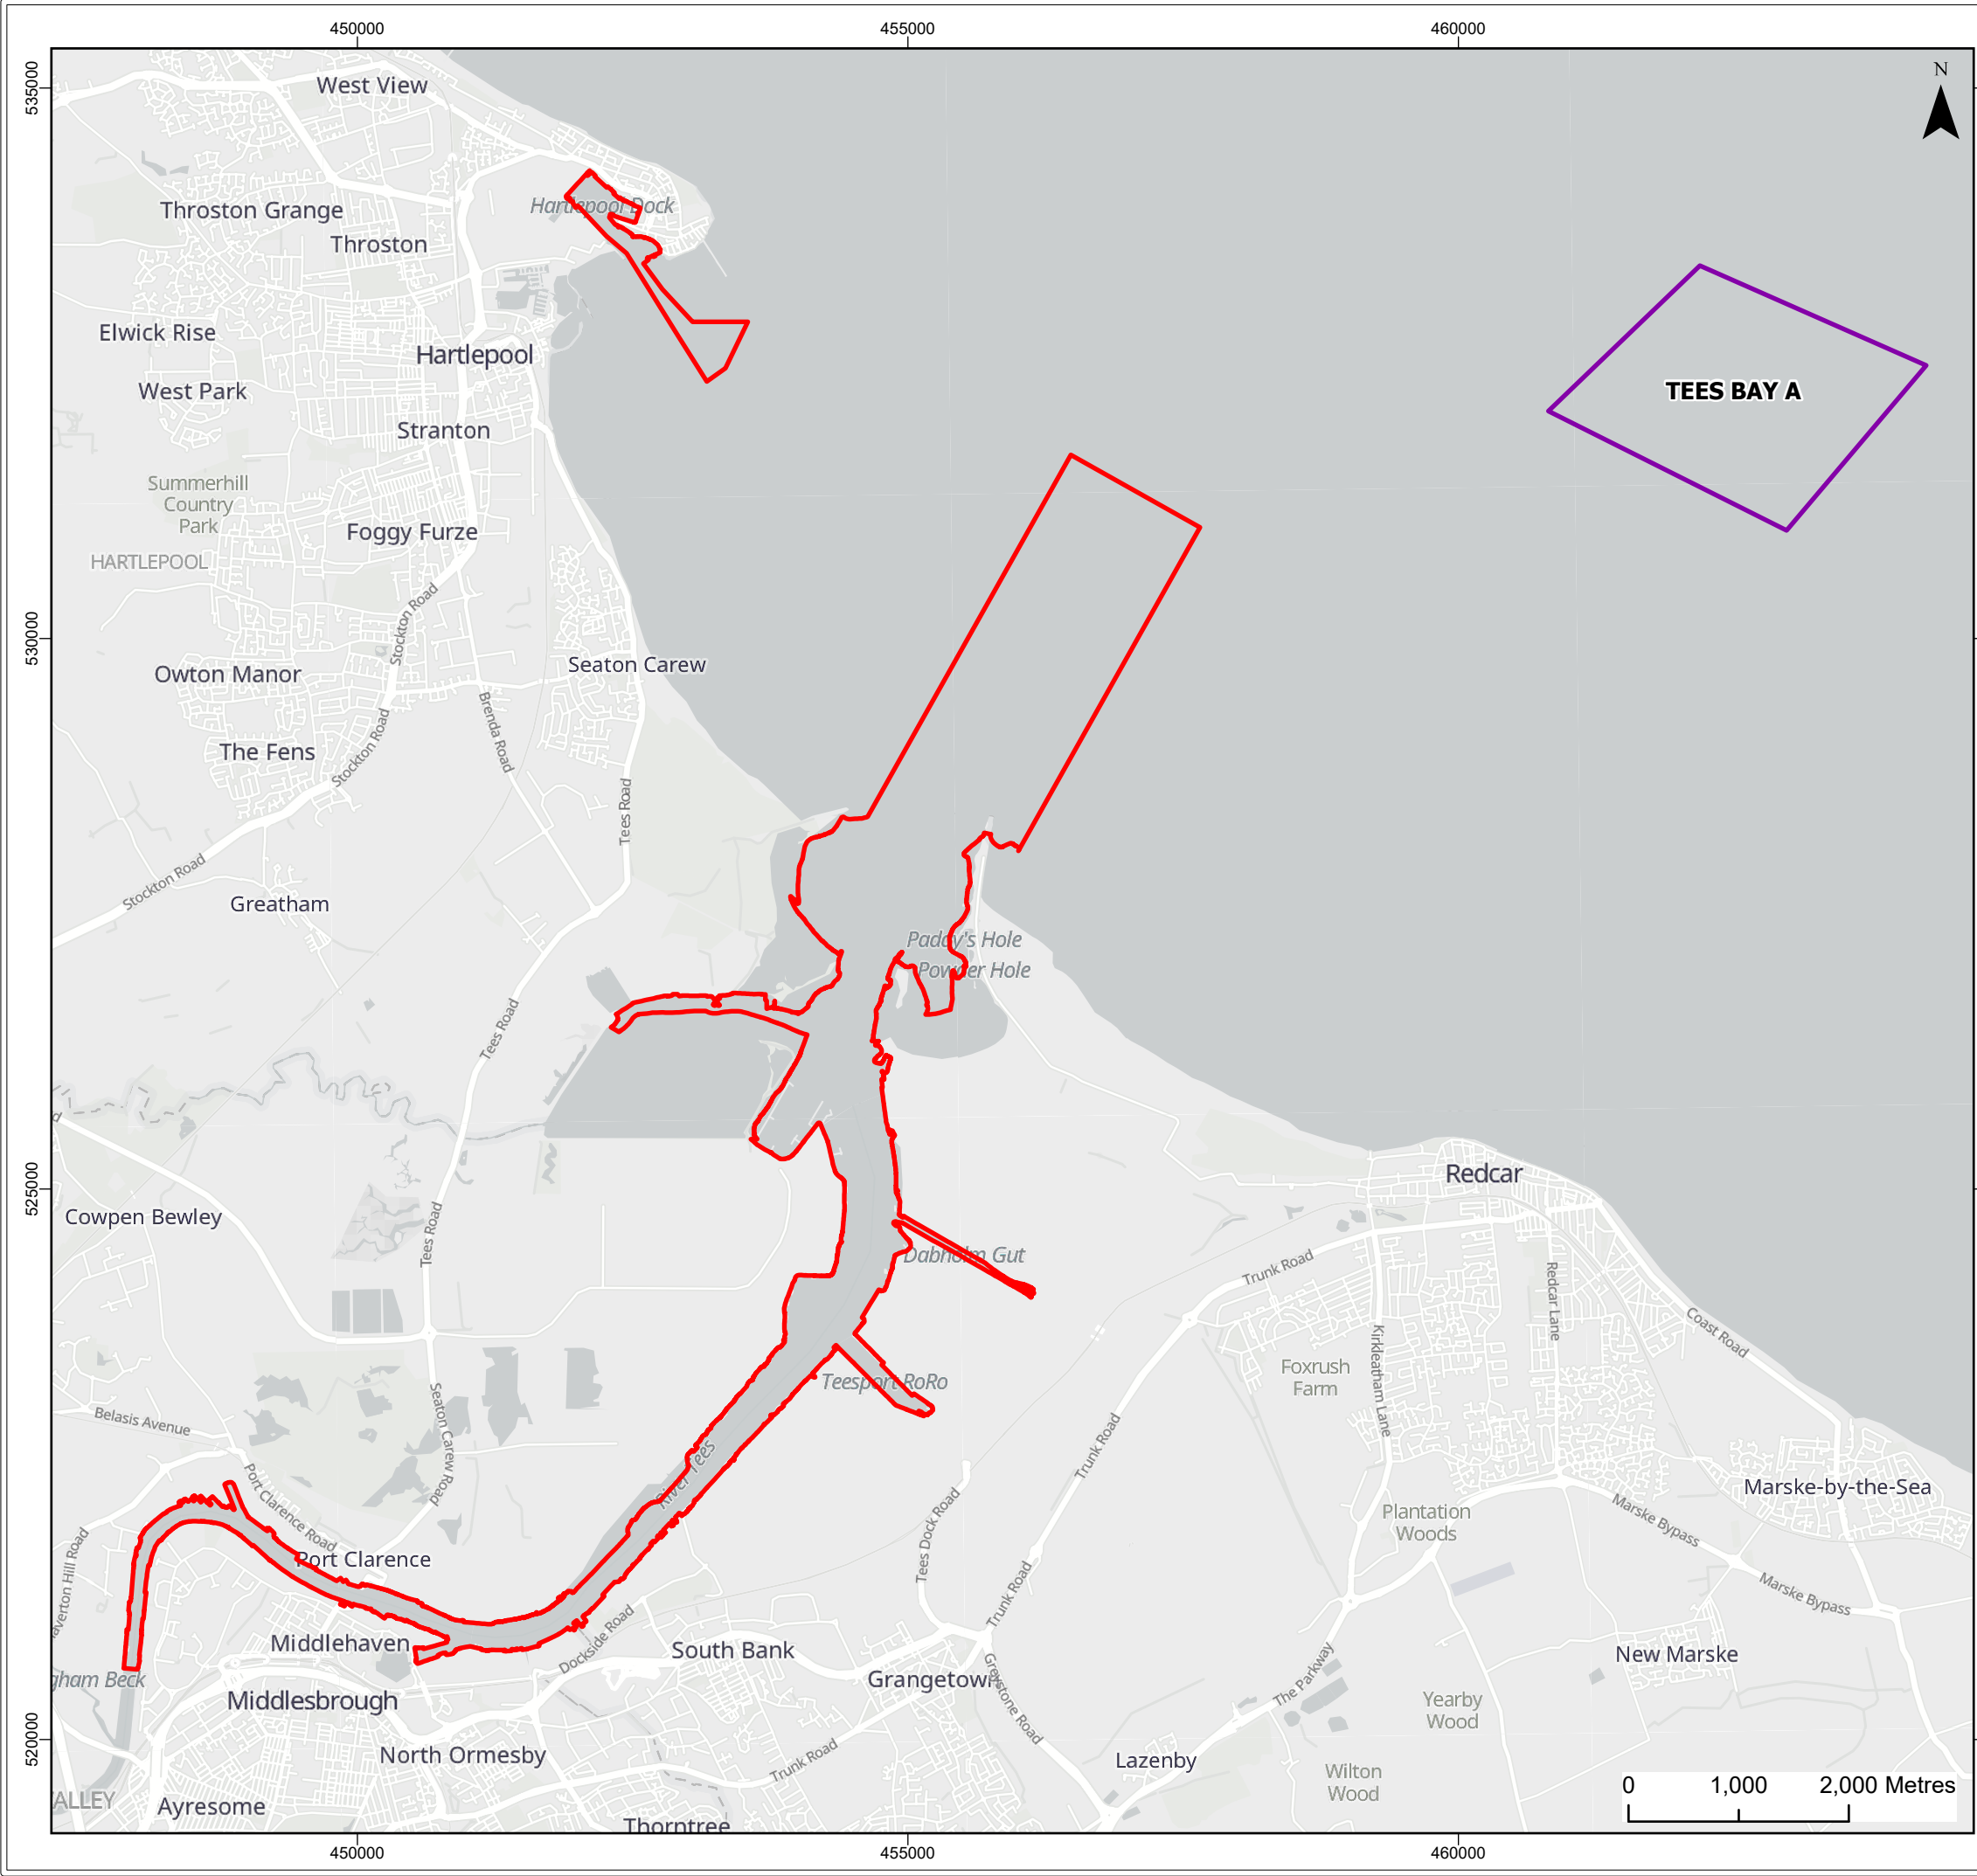
Figure: 2.1

Title:	Maintained areas and Tees Bay A disposal site
--------	---

As part of the 'Clearing the Water for All' guidance a template<sup>3</sup> is provided which covers the first two stages of the assessment. The first table requires details of the activities to be assessed. This has been reproduced below and completed to provide the information required by the Environment Agency. The maintained areas and Tees Bay A disposal site are shown in **Figure 2-1**.

Location of activity	See <b>Figure 2-1</b> . There are two areas listed as source sites in the current marine licence – Tees and Hartlepool. Disposal is at Tees Bay A.
Footprint of activity	See <b>Figure 2-1</b> . Estuary wide with additional area covering Hartlepool.
Timings of activity	Dredging occurs almost on a daily basis, the activity is therefore considered to be continuous. There have been no significant changes to the maintenance dredging regime in the last 10 years.
Use of release of chemicals (state which ones)	The material is sampled for chemical contaminants in line with the conditions of the marine licence – condition 5.2.3 'A regime of future sediment sampling is undertaken, of at least three yearly intervals, which must be agreed in advance with the MMO. Samples must be collected, analysed and the report of their notification signed off prior to dredging in the fourth and subsequently the seventh and tenth year of this licence'.
