South Bank WFD Compliance Assessment

Final Report

October 2021

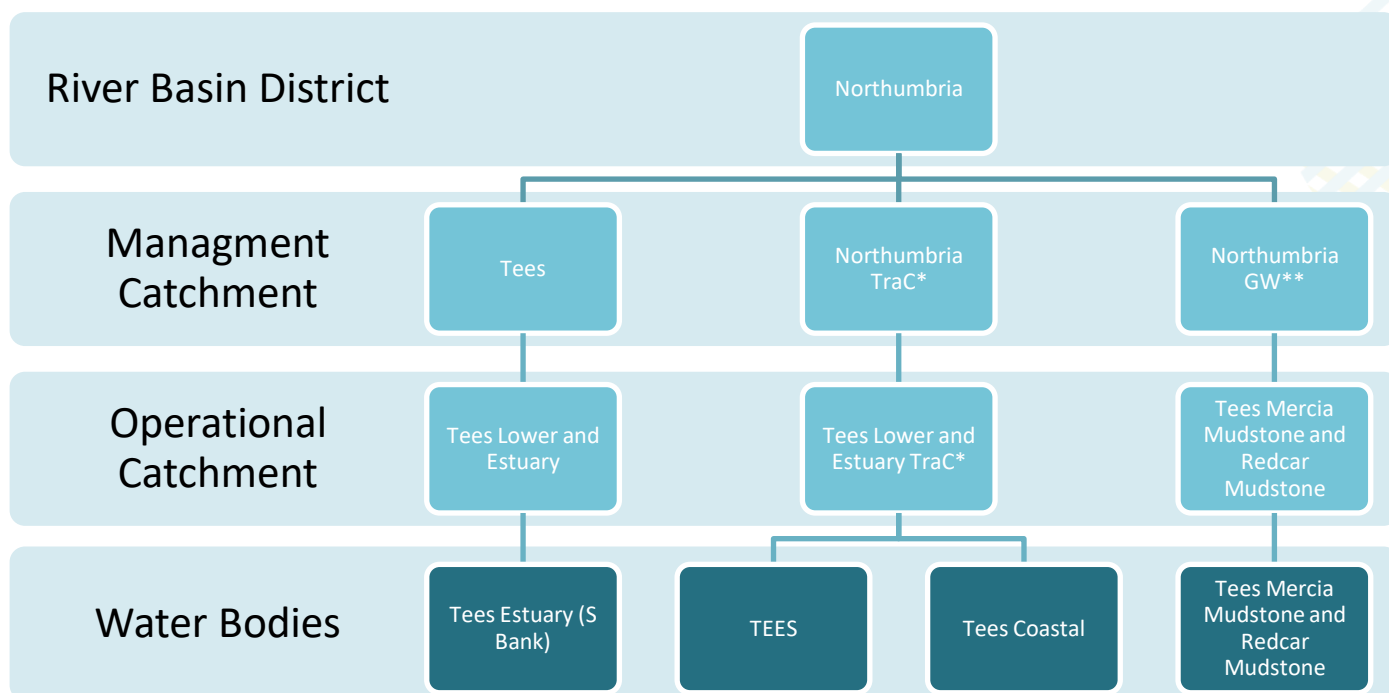
Figure 1-1: WFD water bodies relevant to this study

as well as the area of the site which, although doesn't fall within a WFD water body, is within the RBMP district:

*Transitional water body (Coastal) ** Groundwater

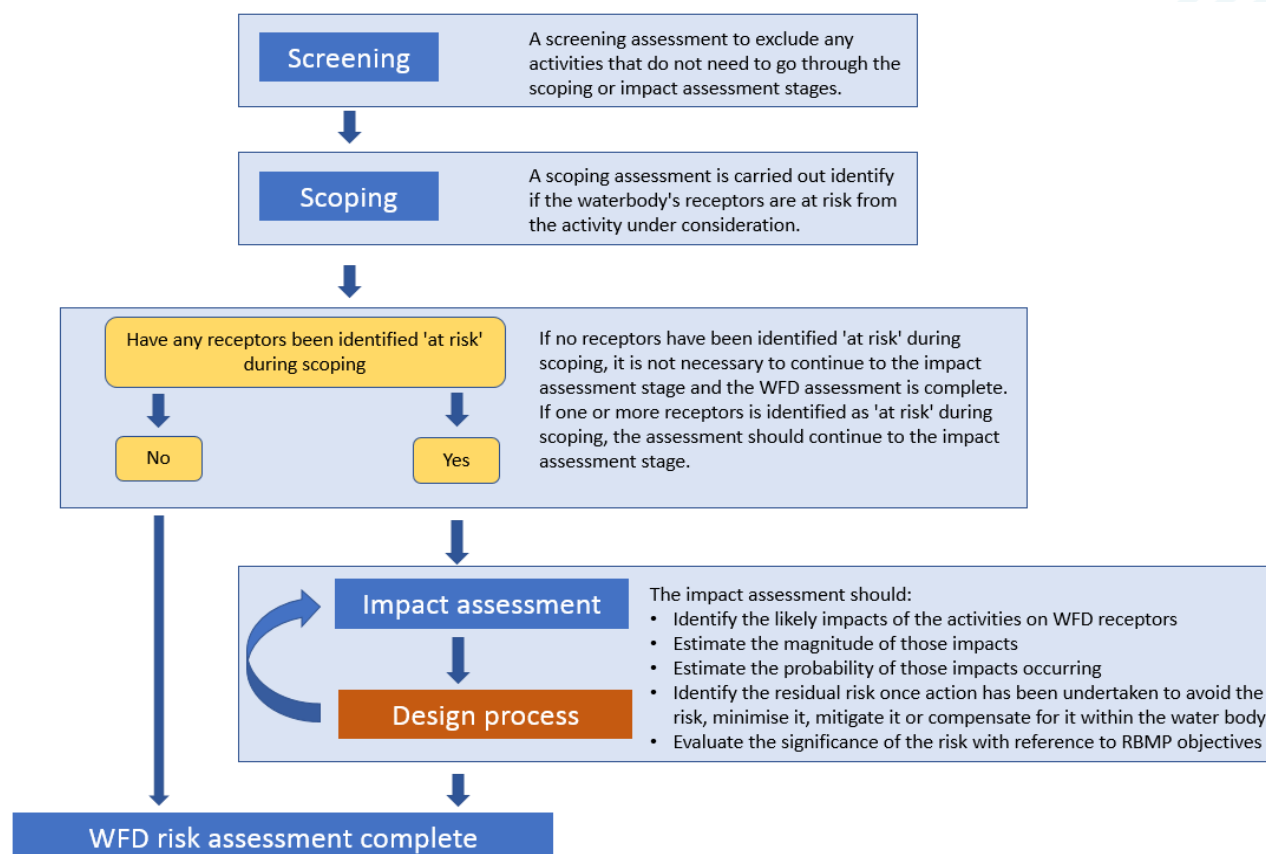
Figure 2-1: WFD assessment process flow chart

The following flow chart summarises the WFD Assessment process.

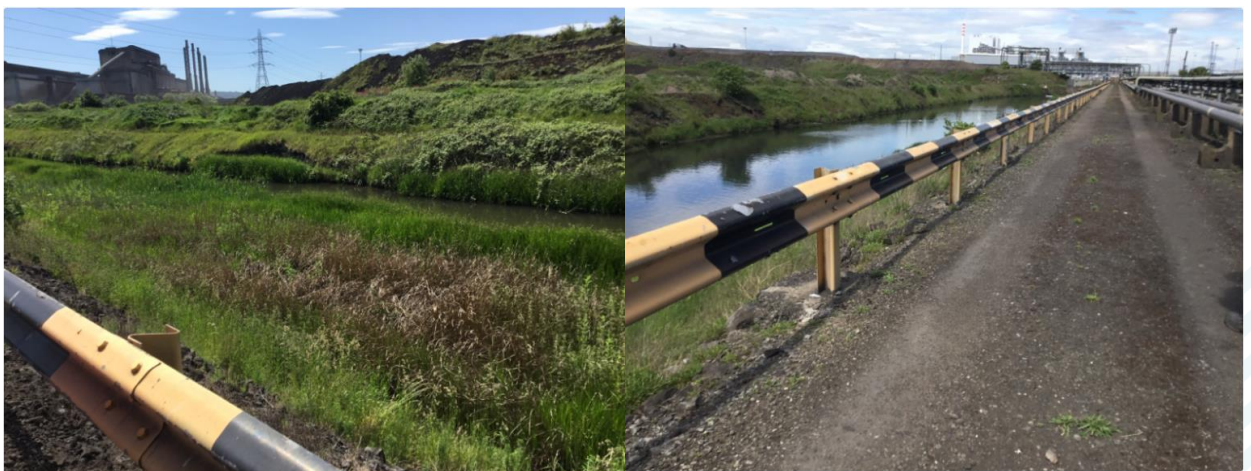
Figure B-3: The Lackenby Channel (Left) looking upstream along the Lackenby Channel, (Right) further downstream both taken from the right bank.

In the Lackenby Channel downstream of the confluence with the Cleveland channel there is an in-channel structure assumed to act as a tidal weir located at NZ 54929 22656.

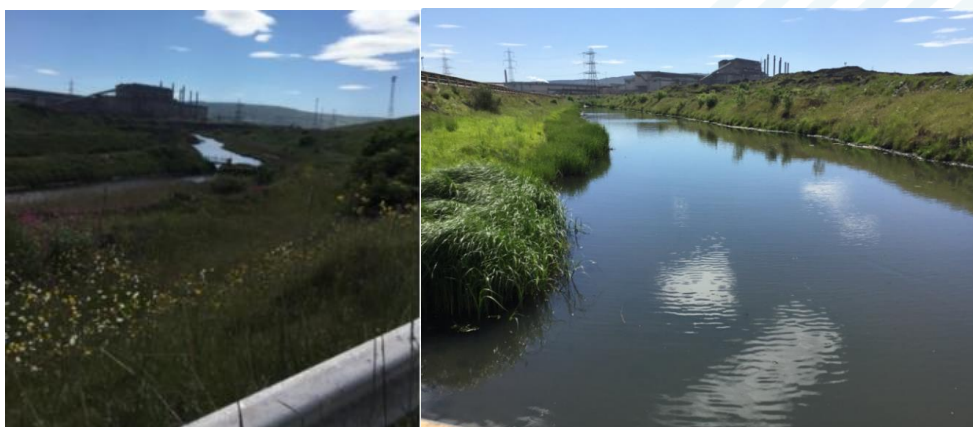
Figure B-4: Cleveland Channel (Left) looking upstream from the left bank, (right) downstream looking from the footbridge crossing the Lackenby channel.

The Cleveland channel receives its flows from Knitting Wife Beck, Cleveland Hills and the culverted upstream reach of the Holme Beck. These channels converge at NZ 54959 22013 and become the Cleveland channel. It is open channel and 1.9 km in length. These also rise on Eston Moor to the south east of the site and is highly urban.

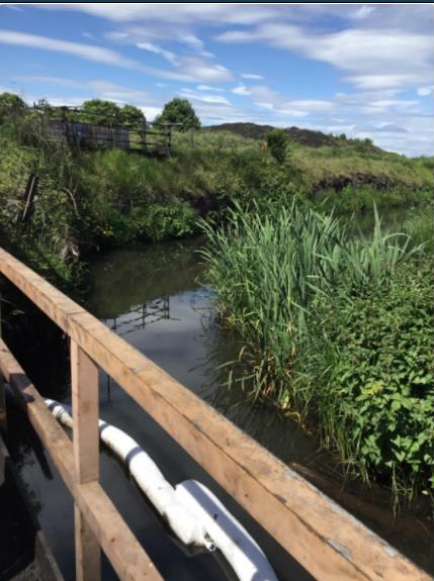
Geomorphology feature	Photograph
<p>1 At this upstream location on the Lackenby channel, looking upstream.</p> <p>The banks are well vegetated with riparian habitat and the channel profile is largely trapezoidal with a straightened planform.</p> <p>Slumping of the banks can be seen along the right bank and reedbed developing on the left bank.</p> <p>There was no indication of high flows or floods, this could have been hidden by vegetation as it had not rained for at least two weeks. No indications of dredging but the site is continually being developed and earth works are moved around the site frequently.</p>

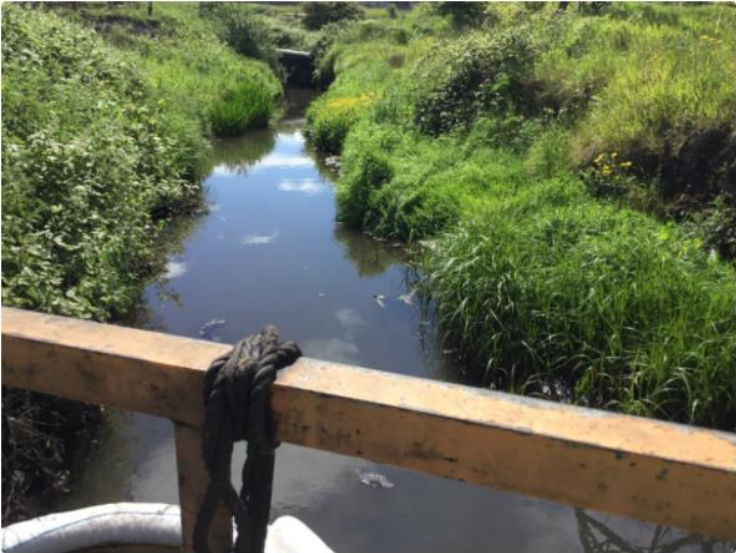
<p>1 Same location as above but looking downstream.</p> <p>The banks are terraced with some slumping features and are well vegetated.</p> <p>Although terraced on the banks, the channel profile is largely trapezoidal with a straightened planform. The slumping banks showed signs of geomorphological recovery as the channel pulls in the banks to readjust the profile, if left to recover it is likely to narrow the channel, increase sinuosity, flow diversity and raise the bed.</p>

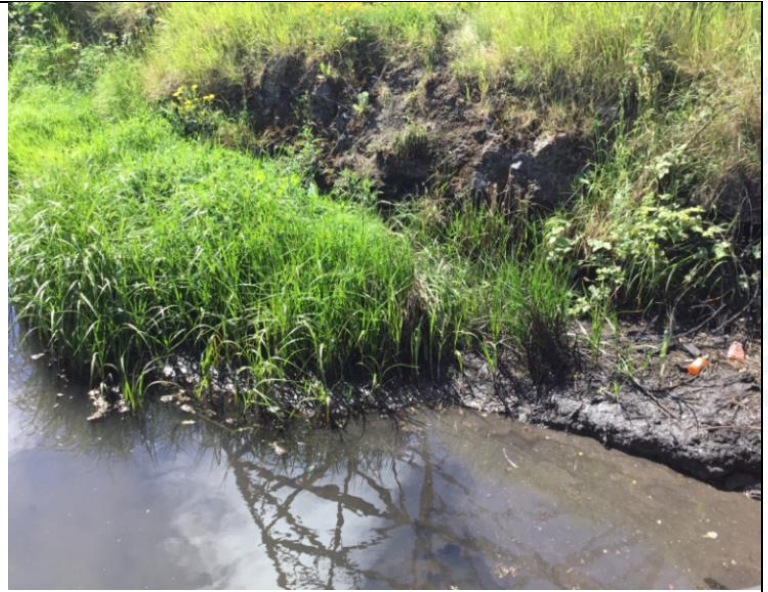
1 Photograph taken looking upstream.
Evidence of banks slumping and depositional areas of mud in the downstream slack areas.

Appears to be developing a reedbed.

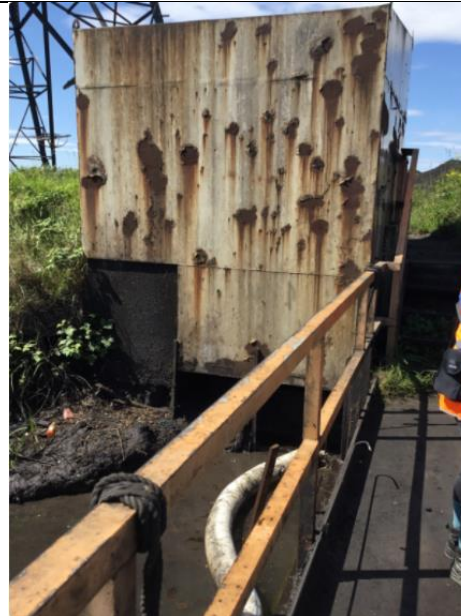
1 Structure is to be removed. Unsure about whether the foot bridge will be removed too.

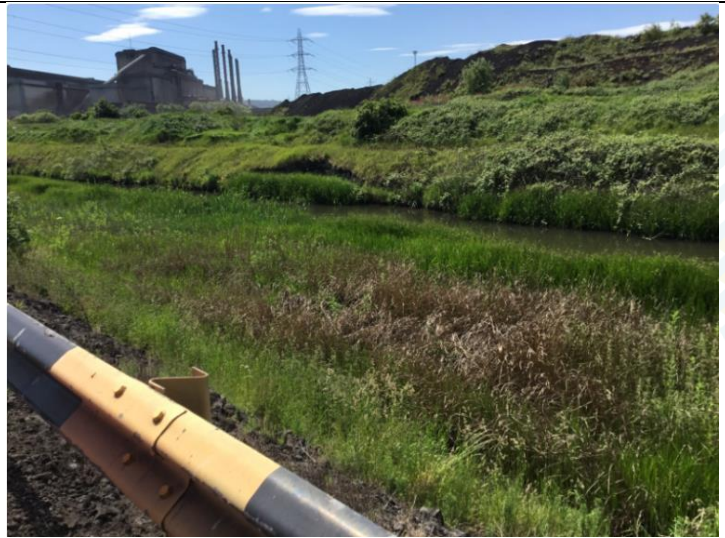
2 Looking upstream.

At 100m downstream of (1) the valley is widened with extensive reedbed and riparian vegetation. The channel is confined within its immediate channel. Could be opportunity to increase sinuosity within this valley. Large woody debris (LWD) could achieve this without the need for interventions with diggers.

Banks are slumping and should be encouraged to recover naturally with these geomorphological processes. LWD in strategic locations can maximise the natural recovery in this reach.

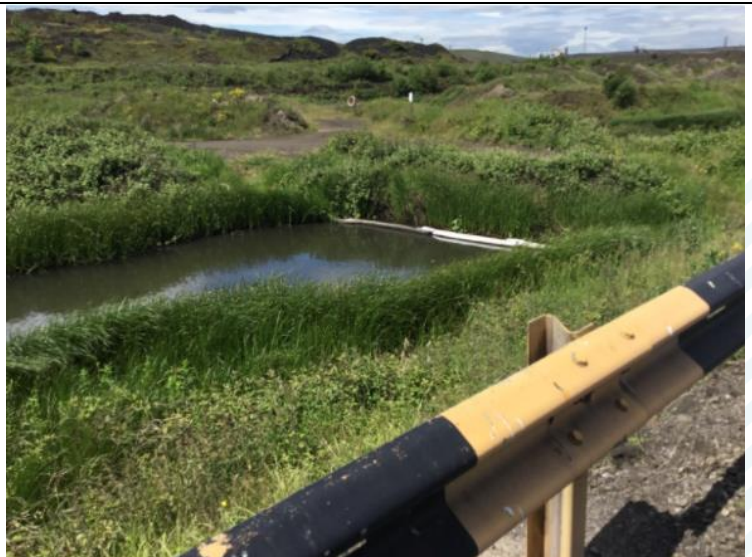
2 Looking downstream.

A vehicular bridge spans this section. If required to maintain access, would recommend over-spanning the bridge to allow natural recovery and avoid expensive hard engineering and maintenance to protect this feature.

The water is not clear and is a muddy brown colour. There is evidence of invertebrates and birds in the water.

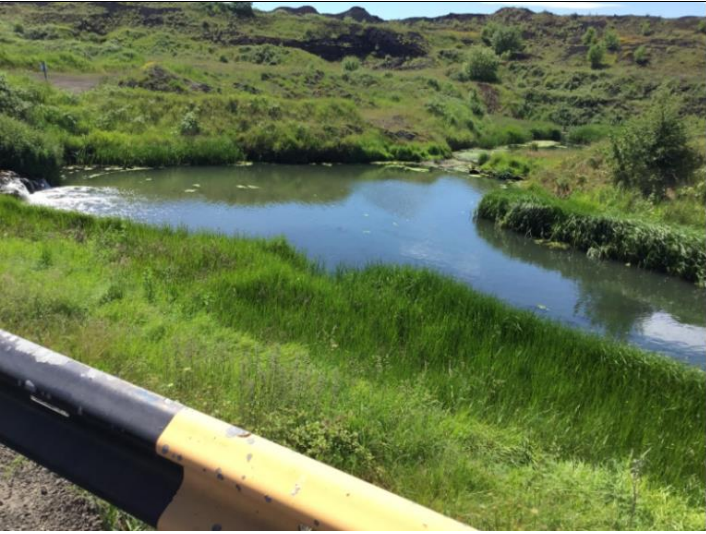
<p>3 Looking upstream from right bank at confluence with Cleveland channel.</p> <p>There is an algal bloom present with a blue/green tinge to the water and algal scum on the surface.</p> <p>Reedbeds are developing on the right bank.</p> <p>There is a weir or raised structure on the Lackenby channel. Opportunity to remove or build fish passage.</p>

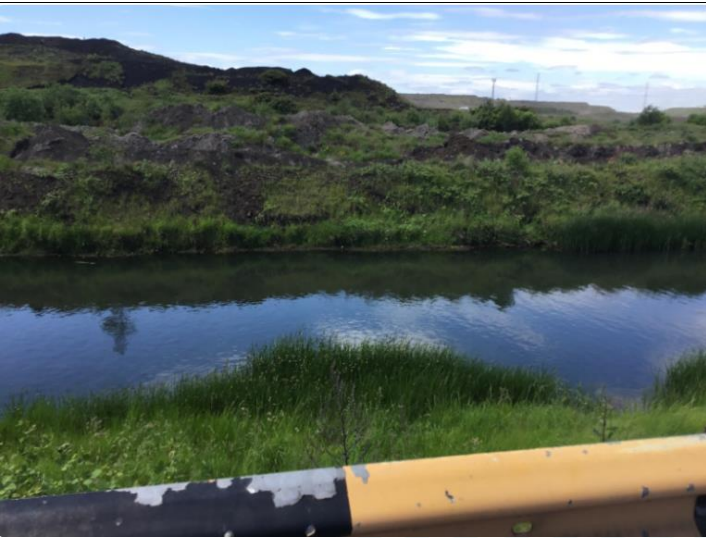
<p>4 Looking across Lackenby from right bank.</p> <p>Vegetation is sparse in this reach, potentially evidence of recent earth works or contamination preventing growth?</p> <p>Reedbed developing on right bank.</p>

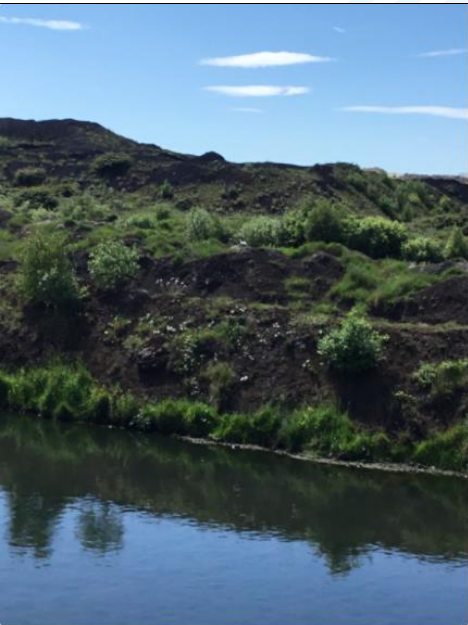
<p>5 Looking across Lackenby from right bank.</p> <p>Vegetation is sparse in this reach, potentially evidence of recent earth works or contamination preventing growth?</p>

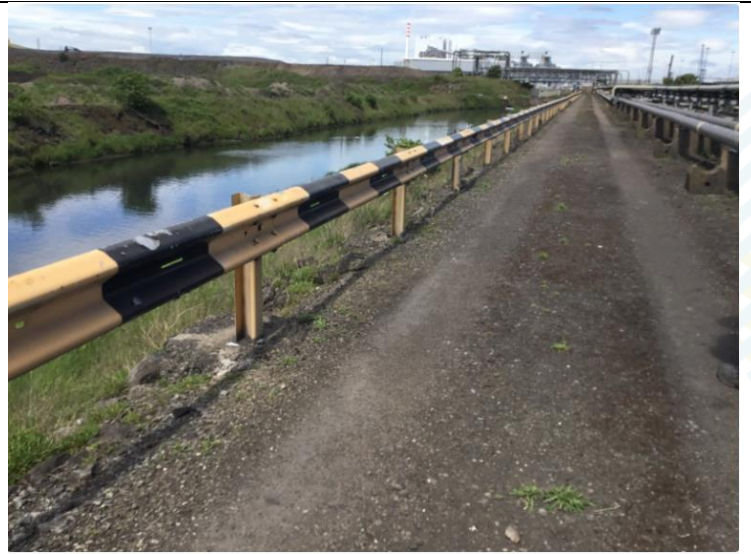
5 Looking downstream on Lackenby from right bank.

This reach has lost the developing recovery seen upstream and is straighter, over wide and trapezoidal, much like a canal.

Opportunities to improve this reach by narrowing the channel, encouraging reedbed growth, installing LWD for flow diversity and to encourage geomorphological processes.

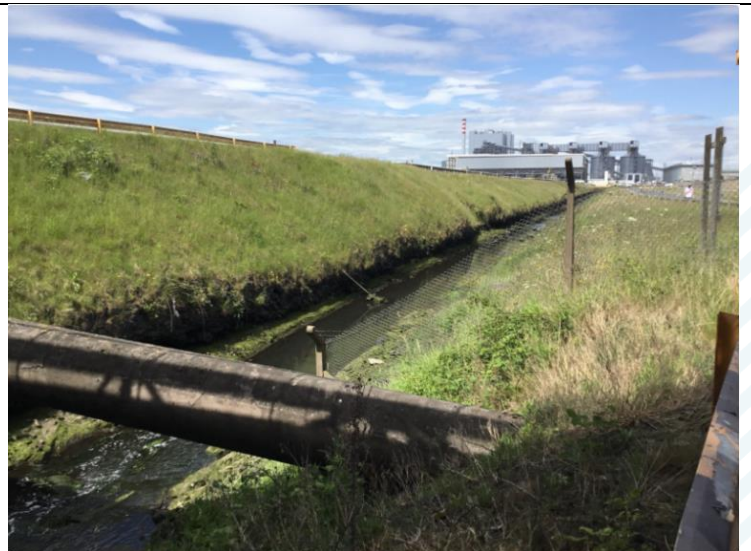
6 Looking downstream on Lackenby from right bank. This reach is outside red boundary towards Tees Port.

This reach is heavily modified with built up protective grassed banks. Banks are becoming undermined and undercut.

Asset to be aware of, pipe crossing the Lackenby channel.

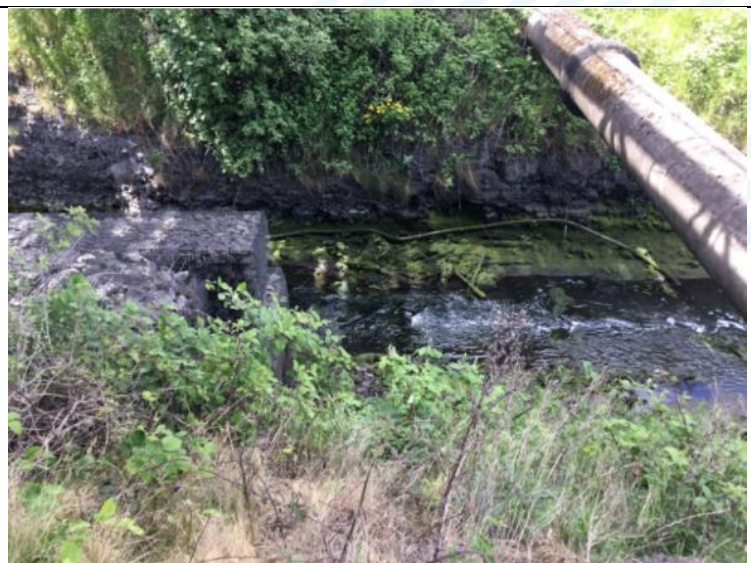
6 Looking across Lackenby from right bank. This reach is outside red boundary towards Tees Port.

Gabion baskets have been installed for increased protection, probably reactionary as the area is becoming undermined.

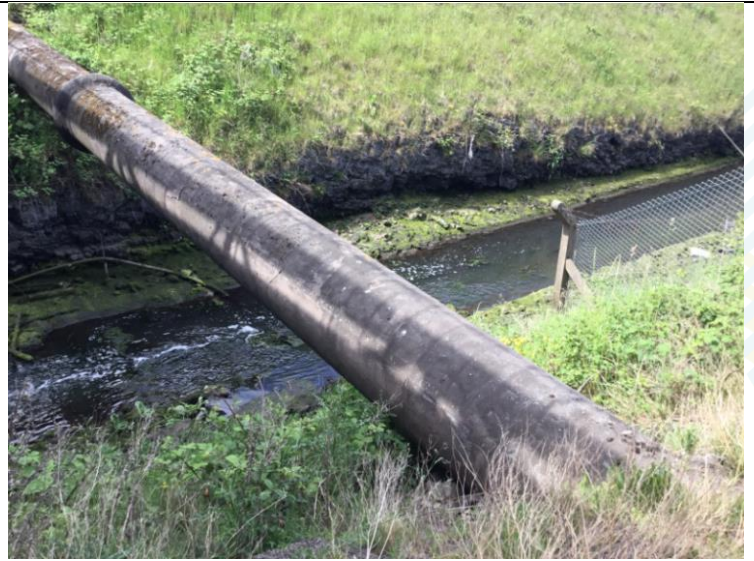
6 Looking downstream on Lackenby from right bank. This reach is outside red boundary towards Tees Port.

Closer look at the pipe asset to be considered and undercutting of protective grassed banks on left bank.

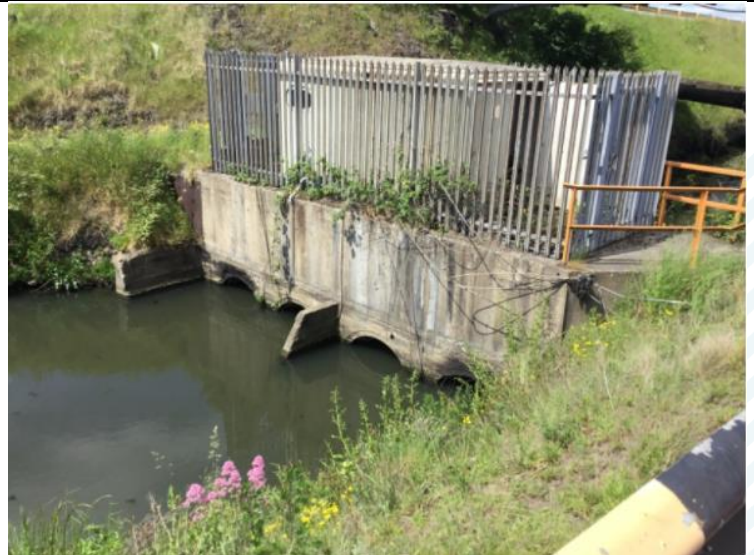
8 Looking downstream on Lackenby channel at potential flow/tidal control structure

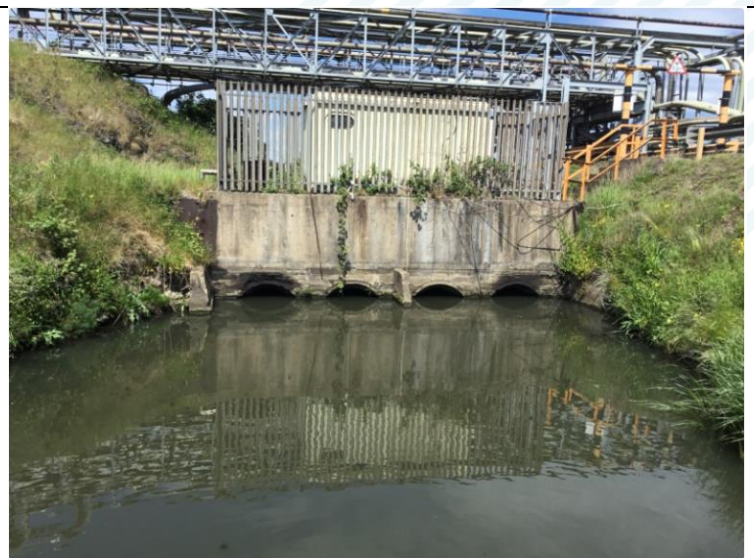
8 Looking downstream on Lackenby channel at potential flow/tidal control structure

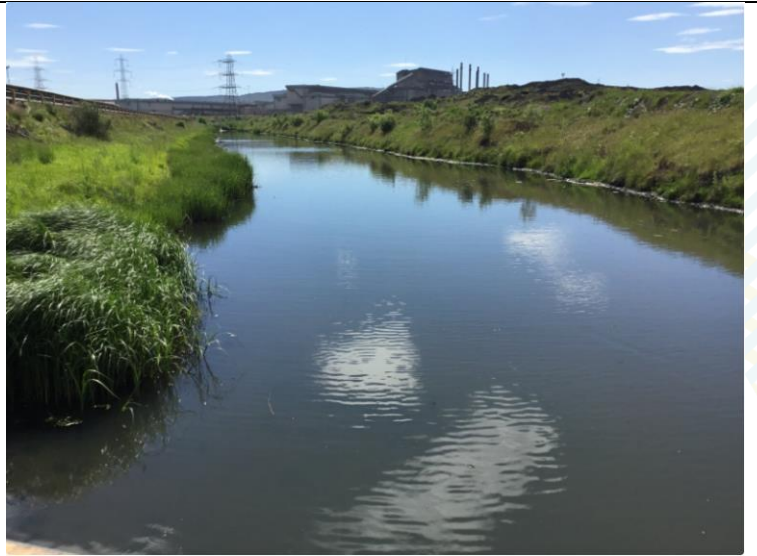
8 Looking upstream on Cleveland channel from footbridge on Lackenby channel.
Reach is over wide and terraced.
Reedbeds are developing on the right bank.

The water appears clearer upstream.

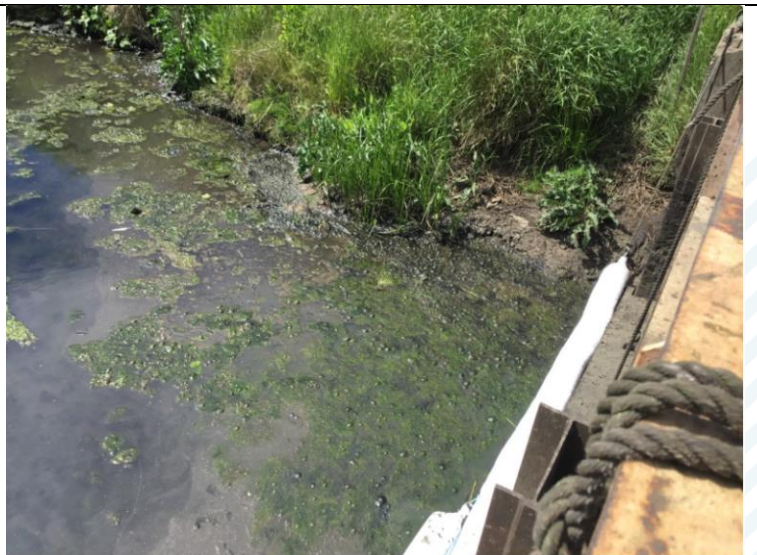
8 Looking at left bank of Cleveland channel from footbridge on Lackenby channel.

Algal scum and maybe other pollutants caught in this slack area. Deposition of mud also visible.

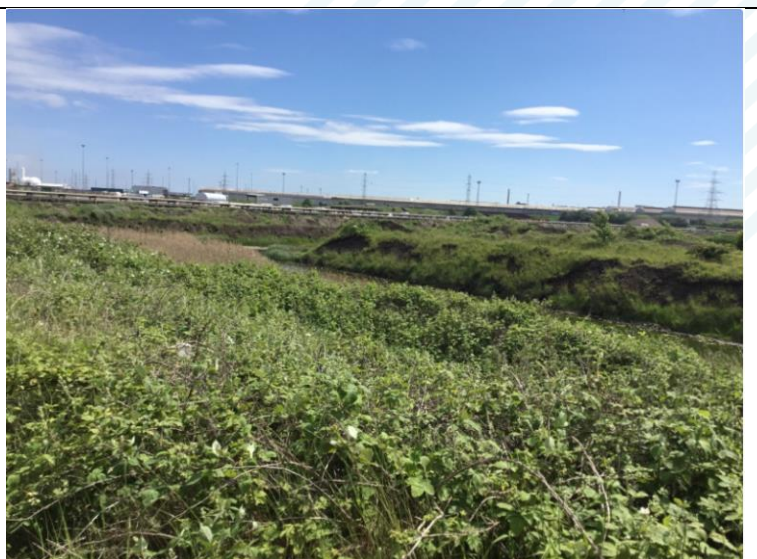
9 Looking downstream Cleveland channel from left bank.

The valley is wide in this reach and has succeeded by reedbeds with a confined channel/thalweg on the right bank.

Another opportunity is to diversity the flow and encourage erosion into reedbeds to create multi-thread channel and increase the ability of the reedbed to cleanse the watercourse.

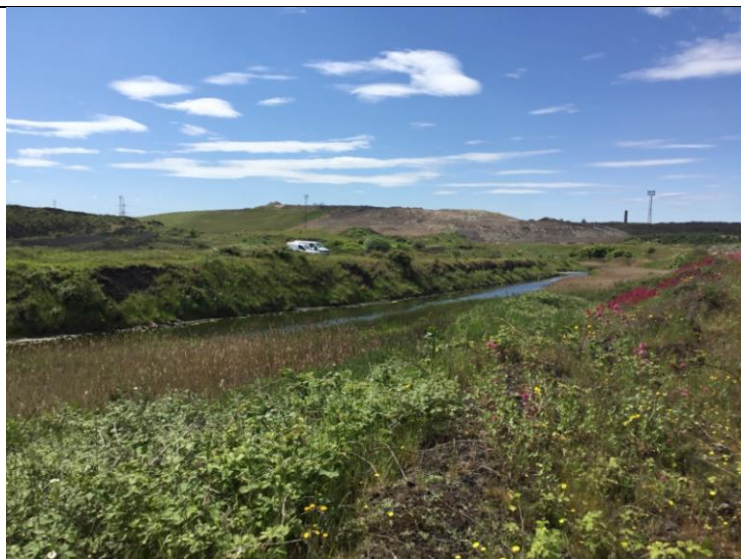
9 Looking upstream Cleveland channel from left bank.

Walking upstream the watercourse and riparian habitat becomes more biodiverse.

Watercourse confined to thalweg.

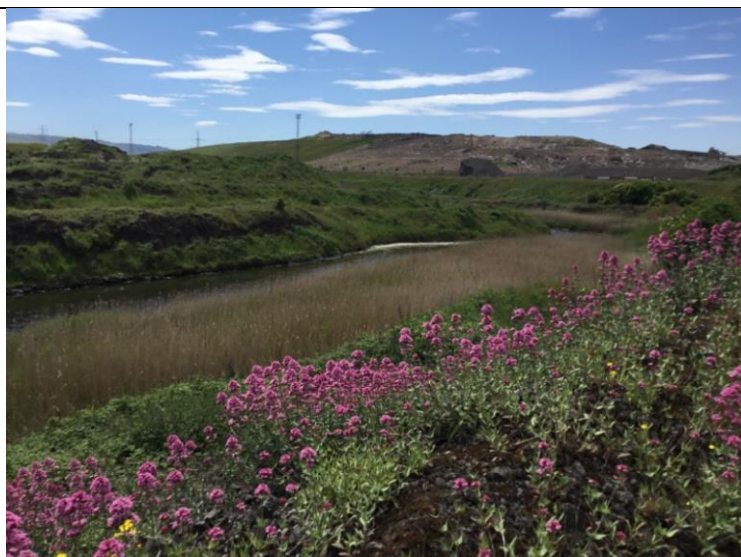
10 Looking upstream Cleveland channel from left bank.

This reach is highly biodiverse with extensive reedbeds and bank slumping.

Watercourse confined to thalweg.

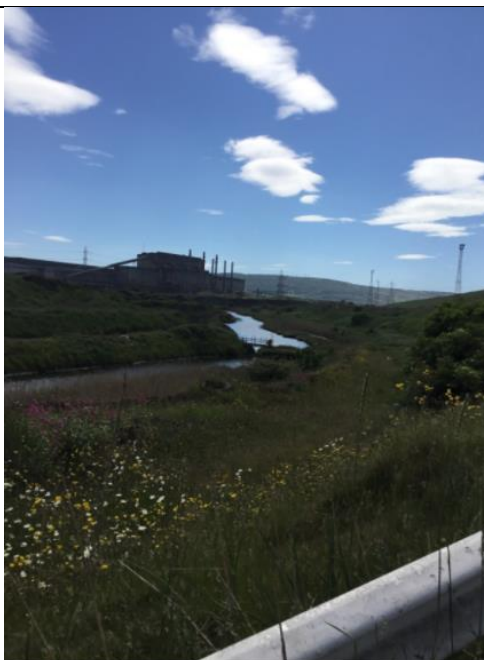
11 Looking upstream Cleveland channel from left bank.

High biodiversity upstream and extensive reedbed.

Watercourse confined to thalweg and straightened planform. Some minor evidence of watercourse attempting to draw in banks and increase sinuosity

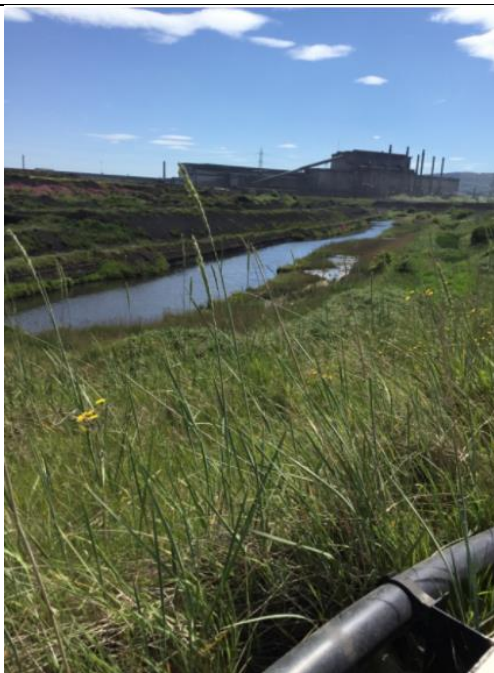
12 Looking upstream Cleveland channel from left bank.

High biodiversity upstream and extensive reedbed.

This was the furthest upstream available to survey due to hazardous dust from site development in the area.
