THE FORMER SSI STEELWORKS, REDCAR – GROUND INVESTIGATION CONTRACT – PRIORITY AREAS WITHIN SSI LANDHOLDINGS CONTRACT 3

Final Factual Report

**Allied
Exploration &
Geotechnics Ltd.**

Date: June 2018

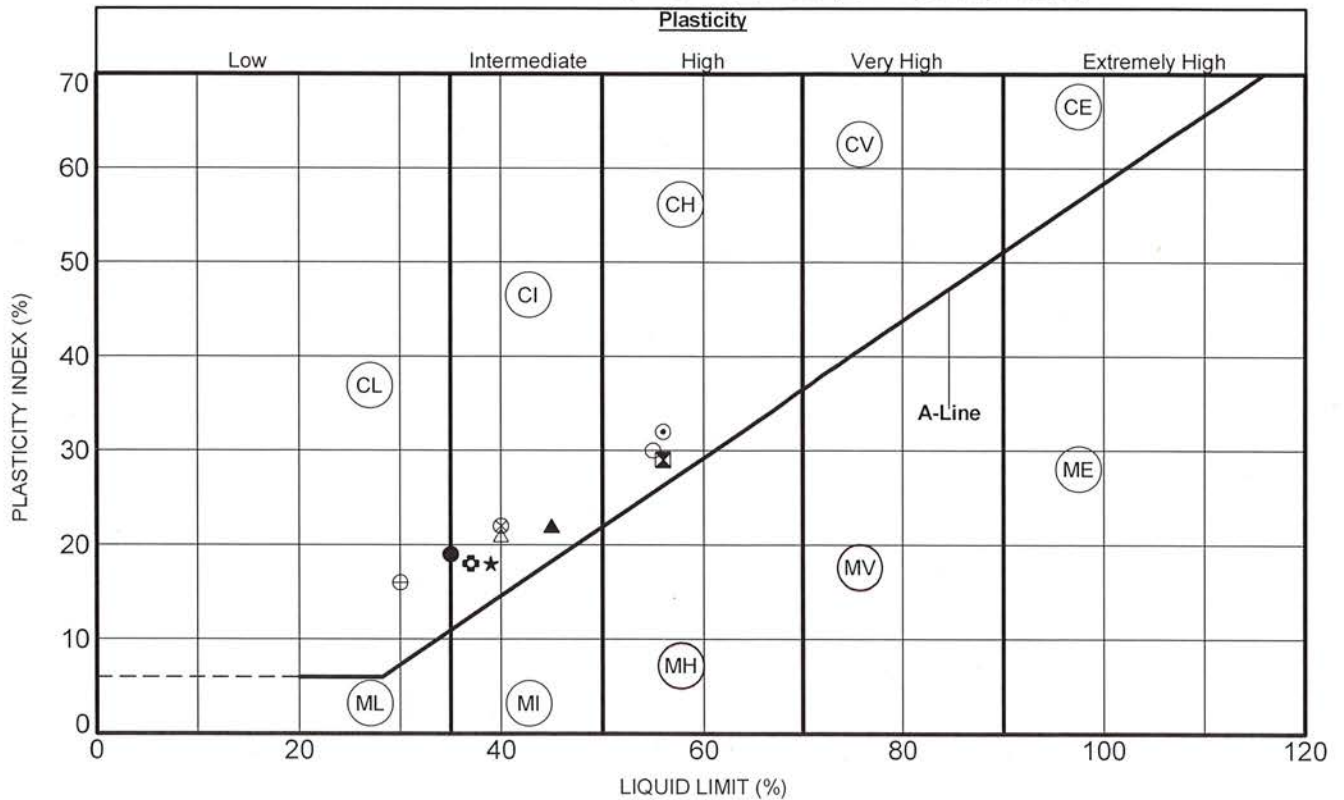
Specimen Identification	LL	PL	PI	I _c	<0.425mm (%)	m/c (%)	Date Tested
● S3-BHA01 5.00 B8	35	16	19	0.82	NAT	19.5	13/12/2017
⊠ S3-BHA02 1.60 B3	56	27	29	0.84	NAT	31.6	13/12/2017
▲ S3-BHA02 2.00 B4	45	23	22	0.91	NAT	24.9	13/12/2017
★ S3-BHA02 3.50 B8	39	21	18	0.76	NAT	25.3	13/12/2017
⊙ S3-BHA02 4.50 J10	56	24	32	0.83	NAT	29.4	12/12/2017
⊕ S3-BHA02 5.50 B11	37	19	18	0.76	53	23.3	13/12/2017 #
○ S3-BHB01 2.80 B3	55	25	30	1.00	NAT	25.1	13/12/2017
△ S3-BHB01 4.00 B9	40	19	21	0.93	NAT	20.5	13/12/2017
⊗ S3-BHB01 6.00 B13	40	18	22	0.82	NAT	21.9	13/12/2017
⊕ S3-BHB01 7.00 B16	30	14	16	0.56	NAT	21.1	13/12/2017

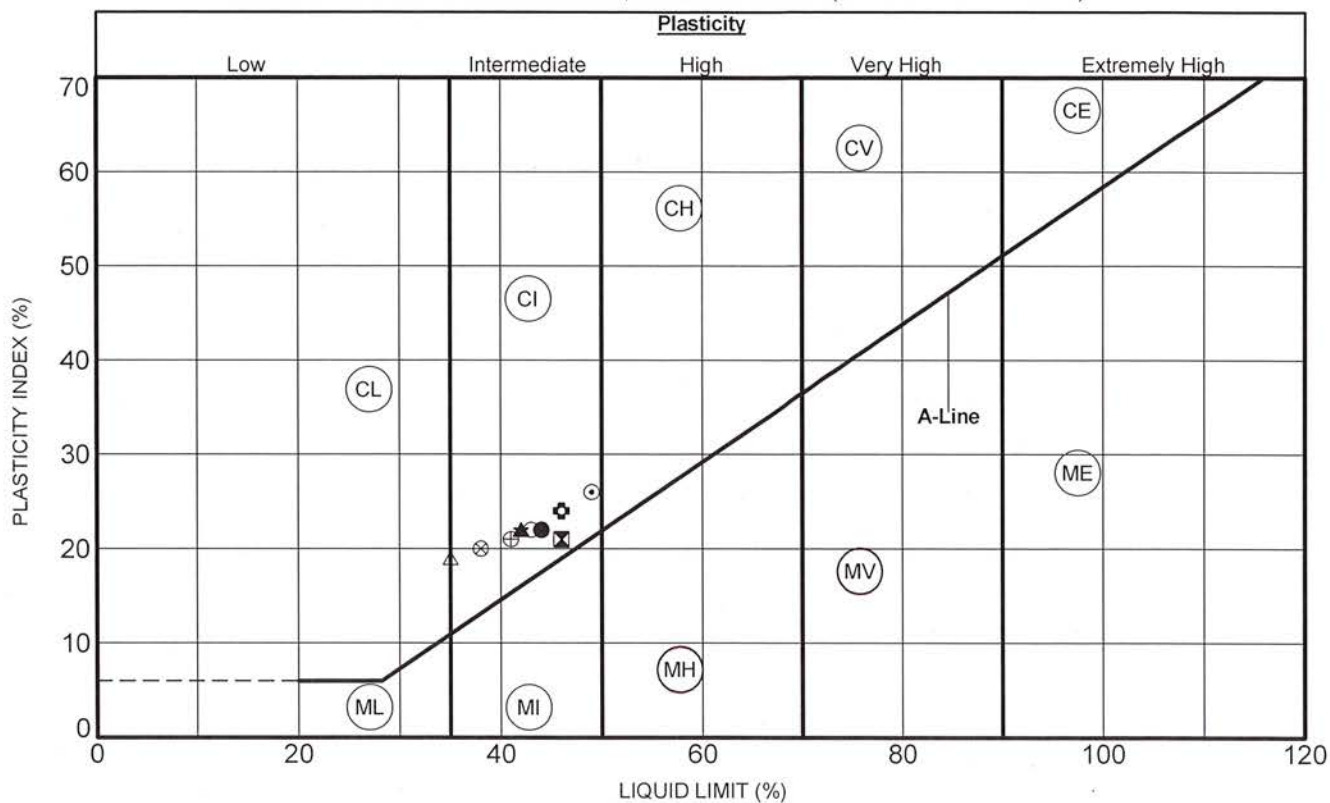
Specimen Identification	LL	PL	PI	I _c	<0.425mm (%)	m/c (%)	Date Tested
● S3-BHB02 2.50 B5	44	22	22	0.95	NAT	23.0	13/12/2017
⊗ S3-BHB02 3.50 B6	46	25	21	1.33	NAT	18.0	13/12/2017
▲ S3-BHB02 4.50 B8	42	20	22	0.19	NAT	37.9	13/12/2017
★ S3-BHB02 5.50 B10	42	20	22	0.53	NAT	30.4	13/12/2017
⊙ S3-BHB02 6.50 B11	49	23	26	0.59	NAT	33.6	13/12/2017
⊕ S3-BHB03 2.50 B5	46	22	24	0.75	NAT	28.1	13/12/2017
○ S3-BHB03 4.50 B8	43	21	22	0.72	NAT	27.1	13/12/2017
△ S3-BHB03 8.00 B14	35	16	19	0.89	NAT	18.0	13/12/2017
⊗ S3-BHB04 3.00 B5	38	18	20	0.40	NAT	30.1	12/12/2017
⊕ S3-BHB04 4.00 B7	41	20	21	0.66	NAT	27.1	13/12/2017

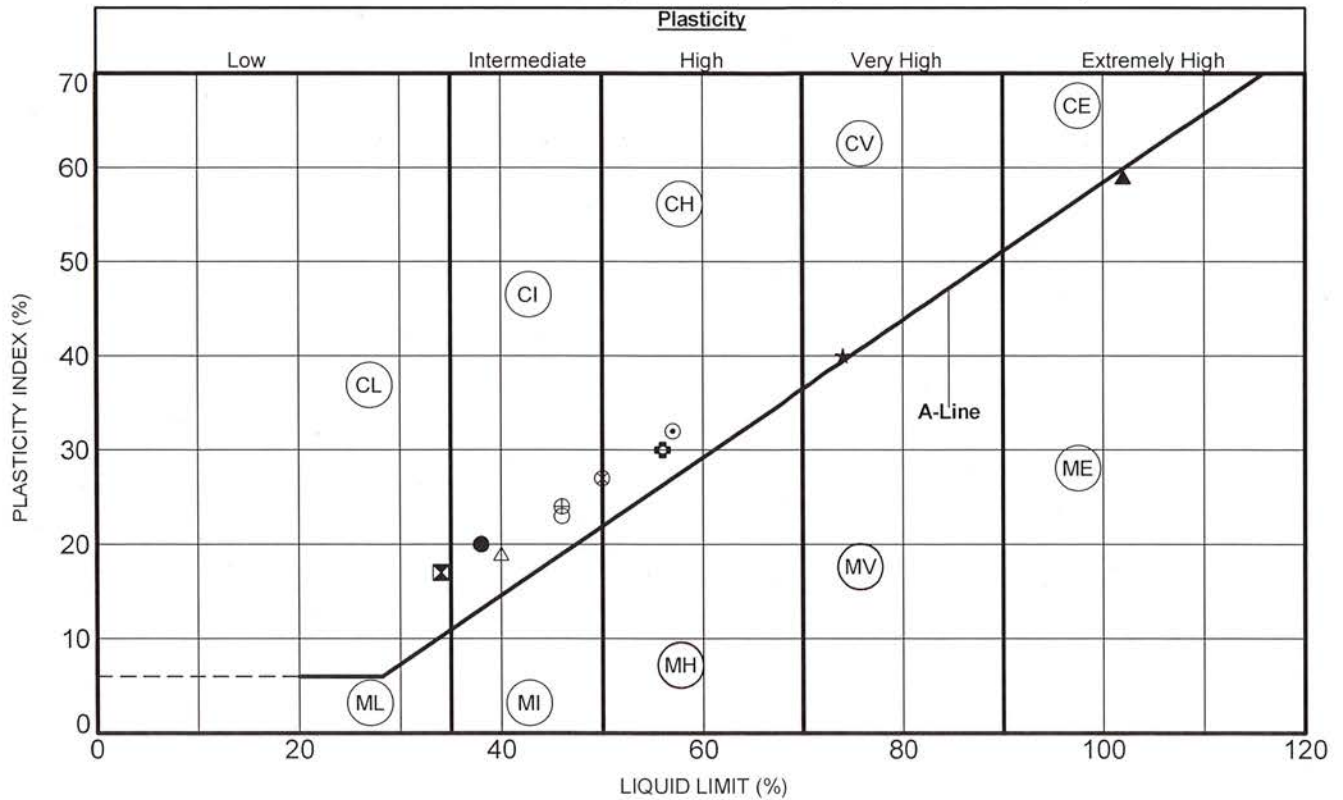
Specimen Identification	LL	PL	PI	I _c	<0.425mm (%)	m/c (%)	Date Tested
● S3-BHB04 6.50 B12	38	18	20	1.00	49	18.1	13/12/2017 #
⊠ S3-BHB04 9.00 B17	34	17	17	0.66	NAT	22.7	13/12/2017
▲ S3-TPA01 3.70 B13	102	43	59	0.90	NAT	49.1	28/11/2017
★ S3-TPA04 2.70 J10	74	34	40	1.20	NAT	25.9	28/11/2017
⊙ S3-TPA09 2.50 J11	57	25	32	0.85	NAT	29.7	12/12/2017
⊕ S3-TPA10 2.50 J11	56	26	30	0.97	NAT	27.0	12/12/2017
○ S3-TPA11 2.90 B10	46	23	23	0.82	NAT	27.1	30/11/2017
△ S3-TPA13 3.20 B10	40	21	19	0.72	NAT	26.3	29/11/2017
⊗ S3-TPA15 2.70 B9	50	23	27	0.87	NAT	26.5	28/11/2017
⊕ S3-TPA17 3.20 B12	46	22	24	0.92	NAT	24.0	28/11/2017

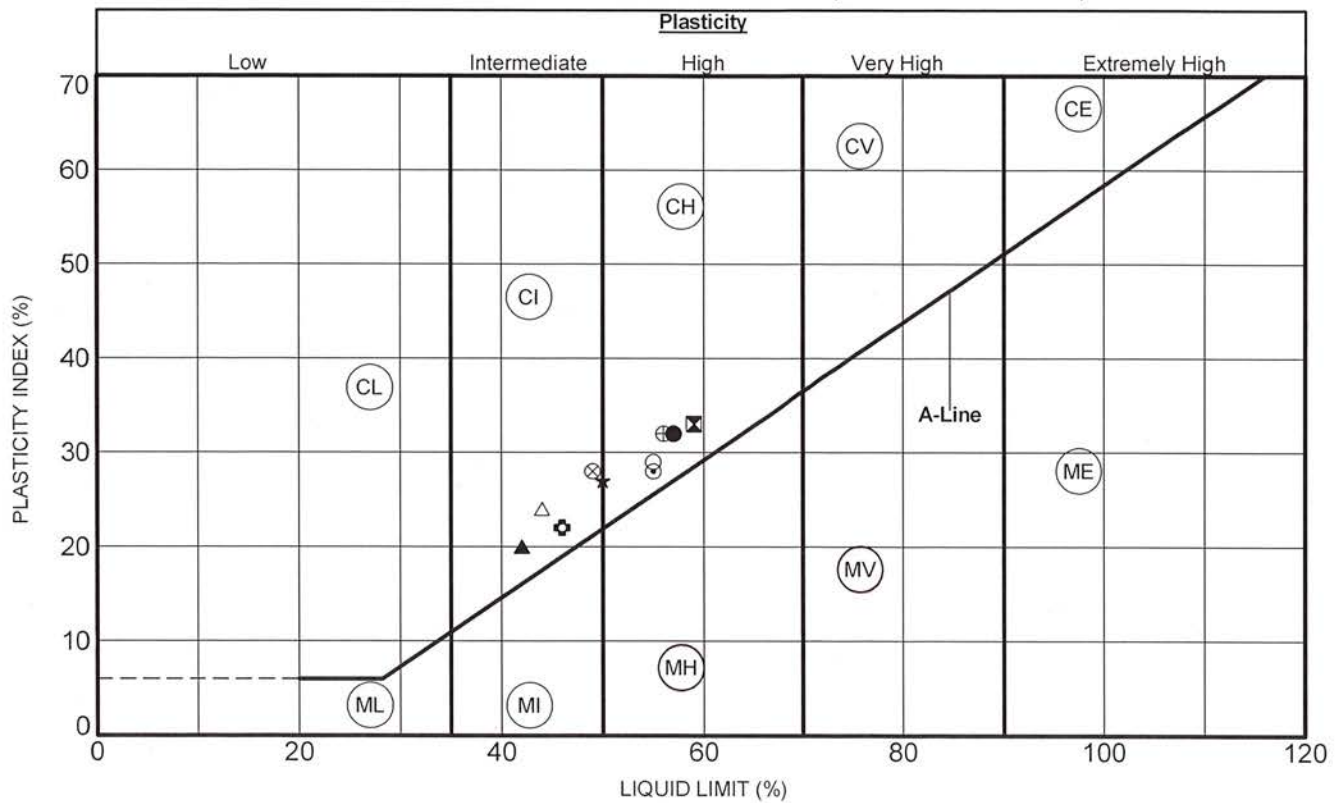
Specimen Identification	LL	PL	PI	I _c	<0.425mm (%)	m/c (%)	Date Tested
● S3-TPA18 3.00 B9	57	25	32	0.96	NAT	26.3	28/11/2017
⊠ S3-TPA19 1.60 B7	59	26	33	1.00	NAT	25.9	10/11/2017
▲ S3-TPA20 2.80 B8	42	22	20	0.85	NAT	25.1	28/11/2017
★ S3-TPA21 1.60 B6	50	23	27	0.88	NAT	26.3	30/11/2017
⊙ S3-TPA22 3.00 B9	55	27	28	0.93	NAT	28.9	27/11/2017
⊕ S3-TPA23 1.70 B6	46	24	22	0.95	NAT	25.1	30/11/2017
○ S3-TPA26 3.50 B12	55	26	29	0.93	NAT	28.0	28/11/2017
△ S3-TPA27 1.50 B6	44	20	24	1.03	NAT	19.2	30/11/2017
⊗ S3-TPA29 2.20 B6	49	21	28	0.92	NAT	23.2	13/12/2017
⊕ S3-TPA30 2.20 B8	56	24	32	0.97	NAT	24.9	30/11/2017

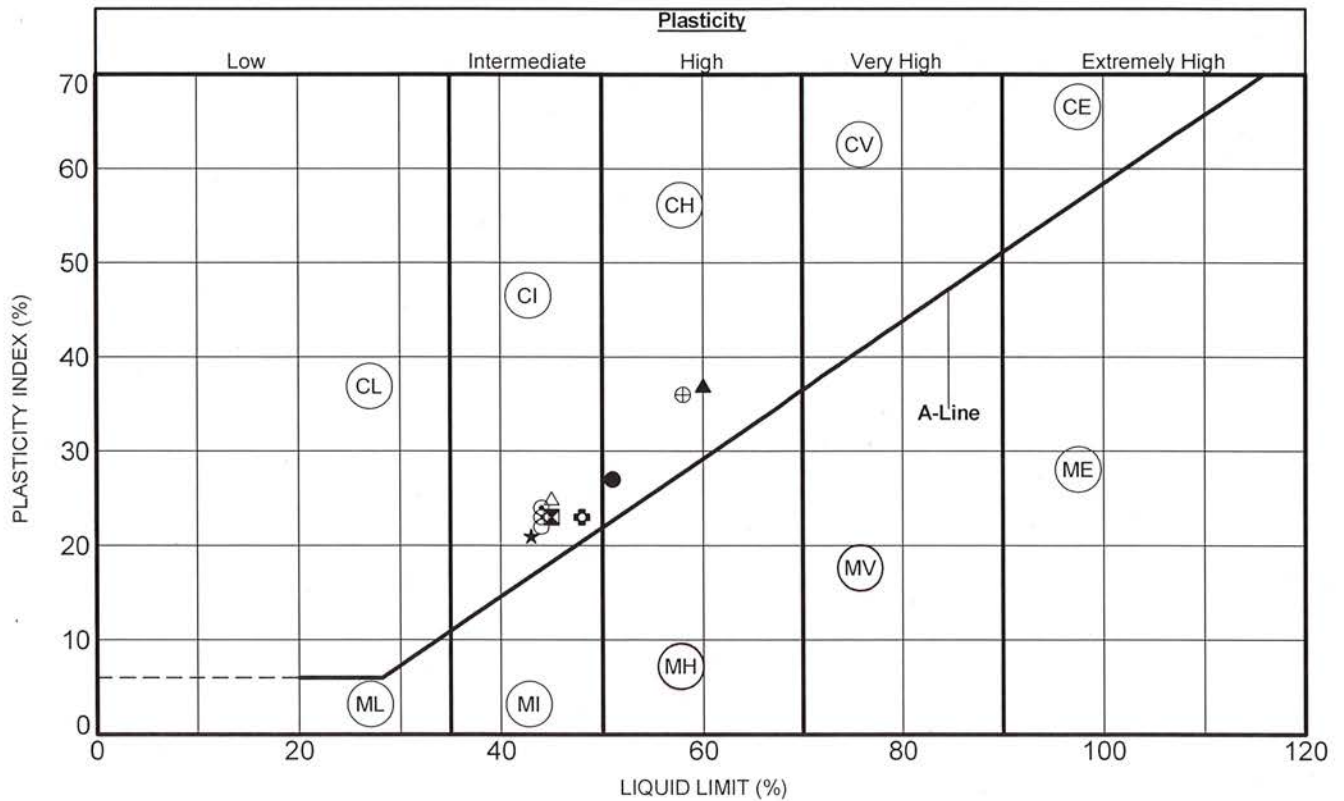
Specimen Identification	LL	PL	PI	I _c	<0.425mm (%)	m/c (%)	Date Tested
● S3-TPA31 2.50 B9	51	24	27	0.93	NAT	25.8	28/11/2017
⊗ S3-TPA32 1.50 J6	45	22	23	0.96	NAT	22.9	12/12/2017
▲ S3-TPA33 1.50 B6	60	23	37	0.89	NAT	27.1	10/11/2017
★ S3-TPA34 2.00 B6	43	22	21	0.86	NAT	24.9	28/11/2017
⊙ S3-TPA35 1.50 B6	44	20	24	0.91	NAT	22.1	10/11/2017
⊕ S3-TPA36 2.00 B7	48	25	23	1.07	NAT	23.3	28/11/2017
○ S3-TPA38 1.50 B6	44	22	22	0.84	NAT	25.6	30/11/2017
△ S3-TPA39 2.00 B8	45	20	25	0.89	NAT	22.8	28/11/2017
⊗ S3-TPA40 1.50 B7	44	21	23	0.91	NAT	23.1	10/11/2017
⊕ S3-TPB01 2.60 B10	58	22	36	0.99	NAT	22.2	28/11/2017

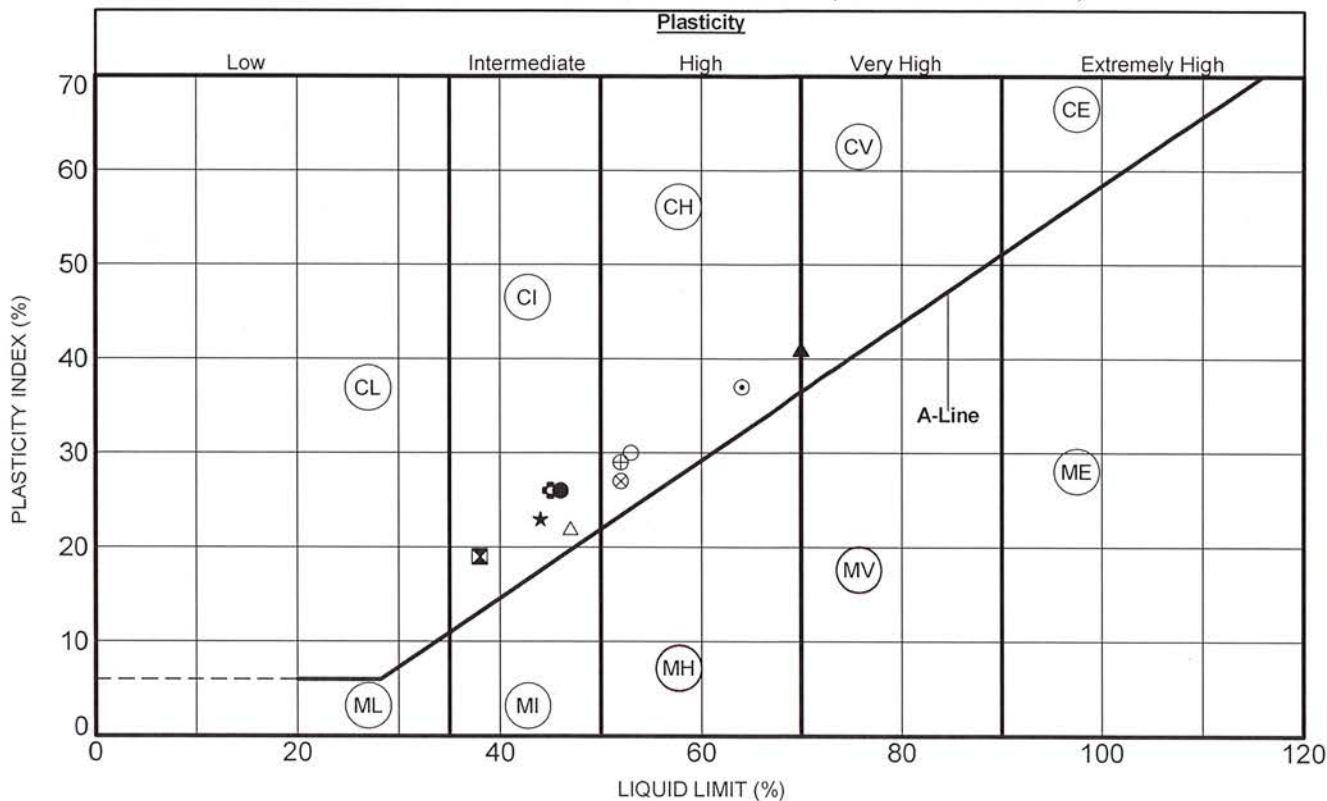
Specimen Identification	LL	PL	PI	I _c	<0.425mm (%)	m/c (%)	Date Tested
● S3-TPB06 1.70 B7	46	20	26	0.92	NAT	22.1	30/11/2017
⊠ S3-TPB12 0.90 B7	38	19	19	0.93	NAT	20.3	28/11/2017
▲ S3-TPB13 2.80 B15	70	29	41	0.88	NAT	33.8	29/11/2017
★ S3-TPB14 2.20 B9	44	21	23	0.92	NAT	22.9	28/11/2017
⊙ S3-TPB18 2.00 J9	64	27	37	0.88	NAT	31.3	01/12/2017
⊕ S3-TPB20 2.00 B7	45	19	26	0.88	NAT	22.2	10/11/2017
○ S3-TPB20 3.00 B10	53	23	30	0.90	NAT	26.1	28/11/2017
△ S3-TPB21 2.00 J10	47	25	22	0.87	NAT	27.9	28/11/2017
⊗ S3-TPB22 2.20 B10	52	25	27	0.97	NAT	25.8	28/11/2017
⊕ S3-TPB24 3.30 B10	52	23	29	0.94	NAT	24.8	28/11/2017

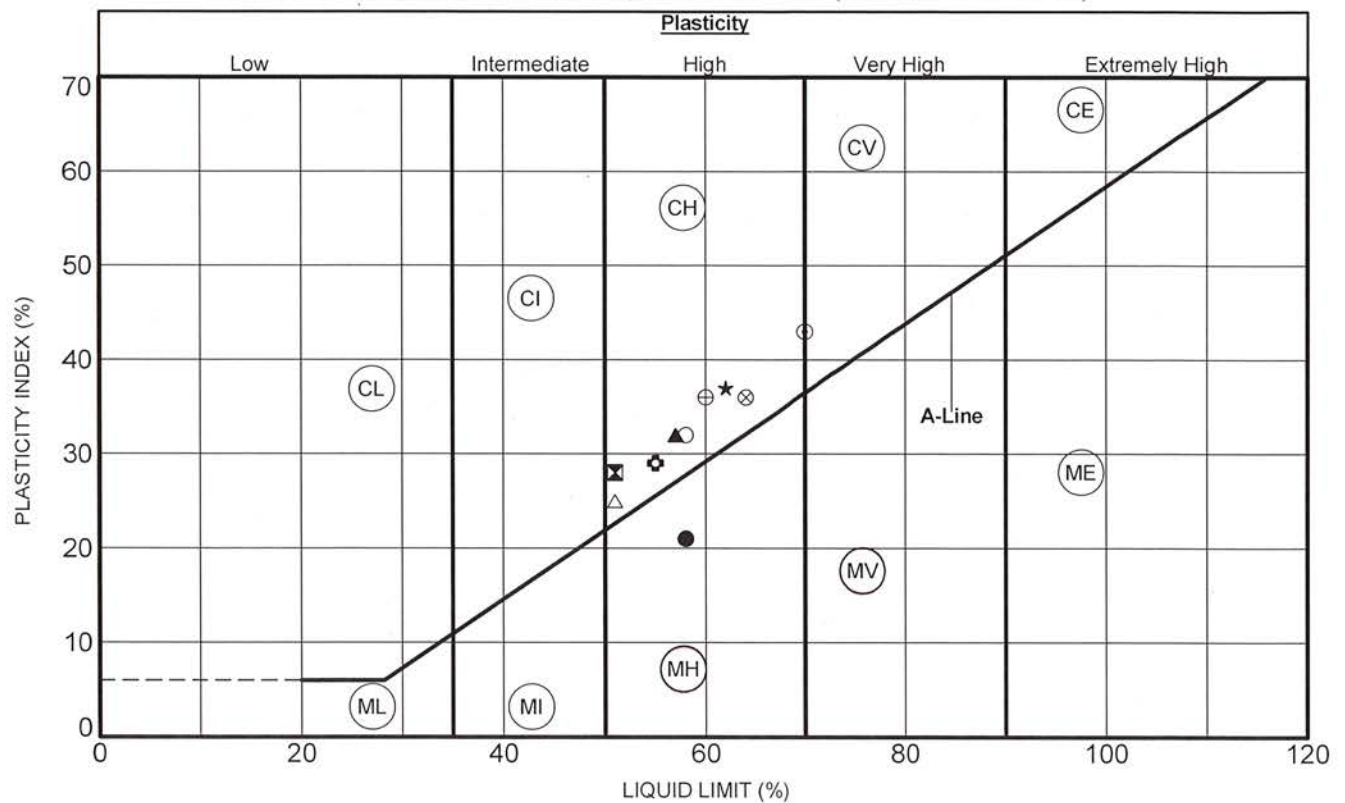
Specimen Identification	LL	PL	PI	I _c	<0.425mm (%)	m/c (%)	Date Tested
● S3-TPB26 1.70 B6	58	37	21	0.53	NAT	46.9	29/11/2017
⊠ S3-TPB29 1.90 B8	51	23	28	0.95	NAT	24.5	28/11/2017
▲ S3-TPB34 2.00 B7	57	25	32	1.02	NAT	24.4	28/11/2017
★ S3-TPB35 1.50 B6	62	25	37	0.89	NAT	29.2	28/11/2017
⊙ S3-TPB37 2.70 B9	70	27	43	0.93	NAT	29.9	29/11/2017
⊗ S3-TPB41 1.50 B6	55	26	29	0.88	NAT	29.6	30/11/2017
○ S3-TPB43 3.50 B9	58	26	32	0.87	NAT	30.2	28/11/2017
△ S3-TPB47 2.50 B8	51	26	25	0.83	NAT	30.3	29/11/2017
⊗ S3-TPB48 2.50 B9	64	28	36	0.92	NAT	30.8	29/11/2017
⊕ S3-TPB51 2.50 B9	60	24	36	0.95	NAT	25.9	28/11/2017

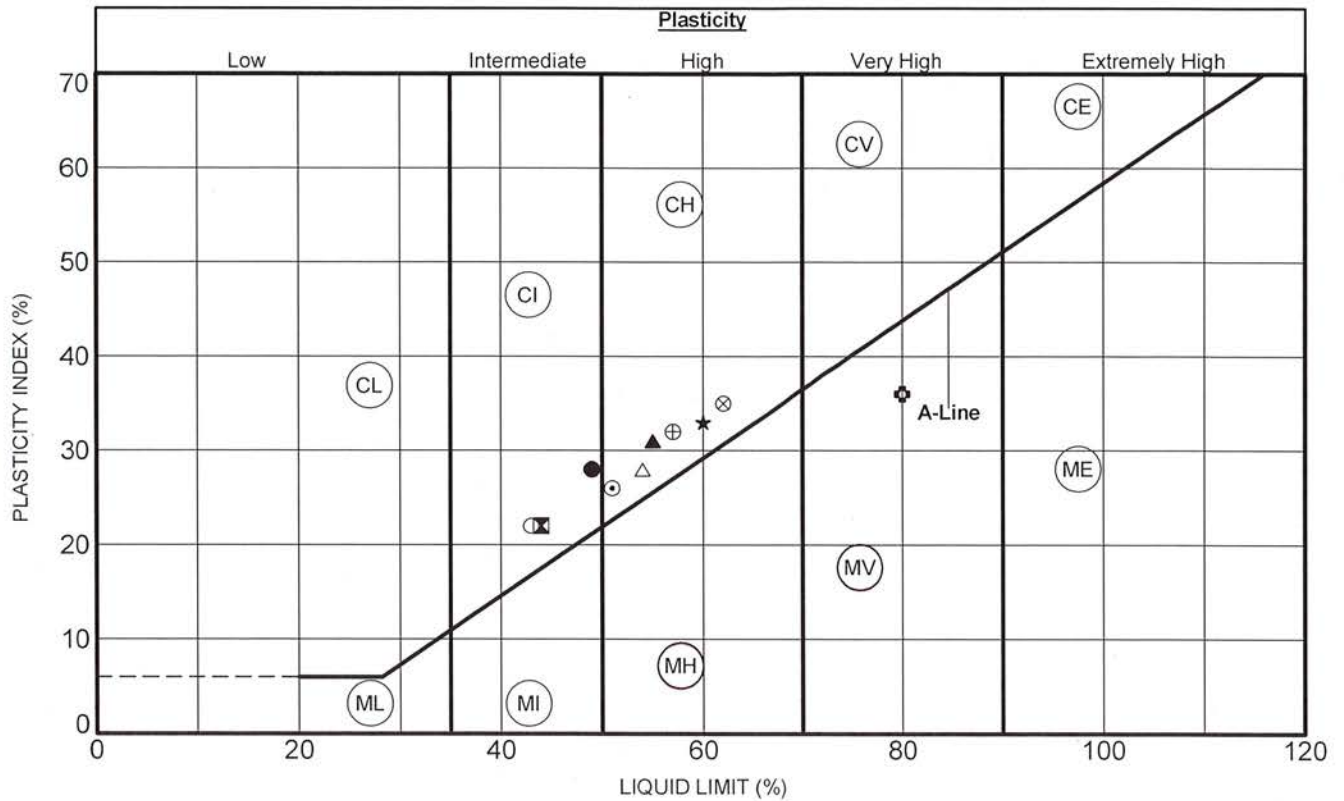
Specimen Identification	LL	PL	PI	I _c	<0.425mm (%)	m/c (%)	Date Tested
● S3-TPB52 2.00 B8	49	21	28	0.86	NAT	24.9	28/11/2017
⊗ S3-TPB53 1.10 B6	44	22	22	0.91	NAT	24.0	27/11/2017
▲ S3-TPB54 2.20 B9	55	24	31	0.85	NAT	28.6	29/11/2017
★ S3-TPB55 2.60 B10	60	27	33	0.99	NAT	27.4	12/12/2017
⊙ S3-TPB56 2.40 B9	51	25	26	0.88	NAT	28.1	30/11/2017
⊕ S3-TPB57 2.40 B9	80	44	36	0.83	NAT	50.3	28/11/2017
○ S3-TPB58 2.40 B9	43	21	22	0.90	NAT	23.1	27/11/2017
△ S3-TPB60 1.50 B7	54	26	28	0.94	NAT	27.7	28/11/2017
⊗ S3-TPB61 2.00 B8	62	27	35	0.92	NAT	29.7	28/11/2017
⊕ S3-TPB63 2.40 B9	57	25	32	0.92	NAT	27.6	28/11/2017

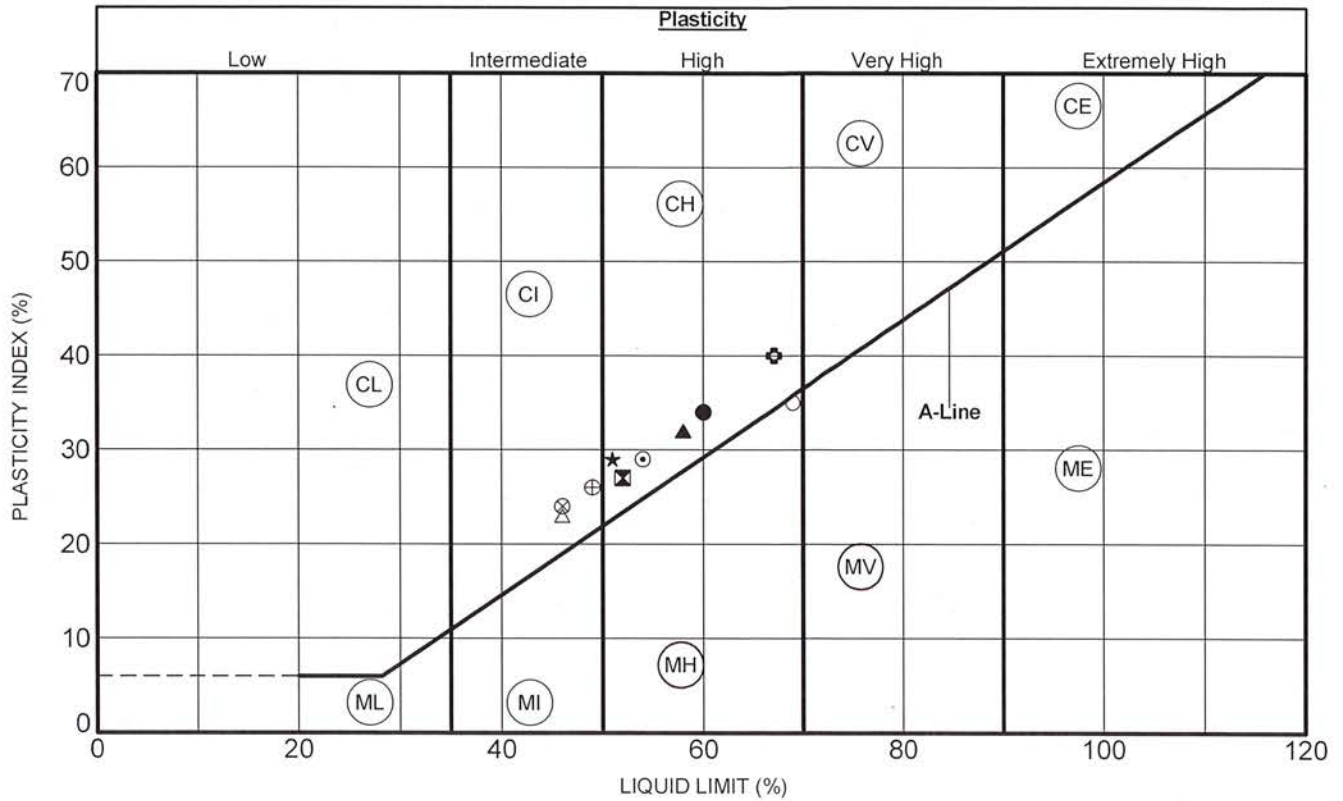
Specimen Identification	LL	PL	PI	I _c	<0.425mm (%)	m/c (%)	Date Tested
● S3-TPB64 2.50 B9	60	26	34	1.05	NAT	24.3	28/11/2017
⊠ S3-TPB67 2.80 J9	52	25	27	0.90	NAT	27.7	01/12/2017
▲ S3-TPB68 2.00 B9	58	26	32	0.87	NAT	30.2	30/11/2017
★ S3-TPB69 1.90 B8	51	22	29	0.83	NAT	26.9	30/11/2017
⊙ S3-TPB70 2.30 B10	54	25	29	1.03	NAT	24.2	28/11/2017
⊕ S3-TPB71 2.20 B7	67	27	40	0.91	NAT	30.8	30/11/2017
○ S3-TPB72 2.50 B10	69	34	35	0.93	NAT	36.5	30/11/2017
△ S3-TPB73 2.50 B10	46	23	23	1.12	NAT	20.3	30/11/2017
⊗ S3-TPB74 1.50 B6	46	22	24	0.96	NAT	23.0	30/11/2017
⊕ S3-TPB75 1.50 B6	49	23	26	1.03	NAT	22.3	30/11/2017
